SERVICE LETTER October 08-02

This Service Letter is for up-dating the “closed” inside labels of the “gull wing door” handles, and general inspection of the handles / doors area.

The affected models are aircraft CH 2000 serial numbers 20-0002 and up.

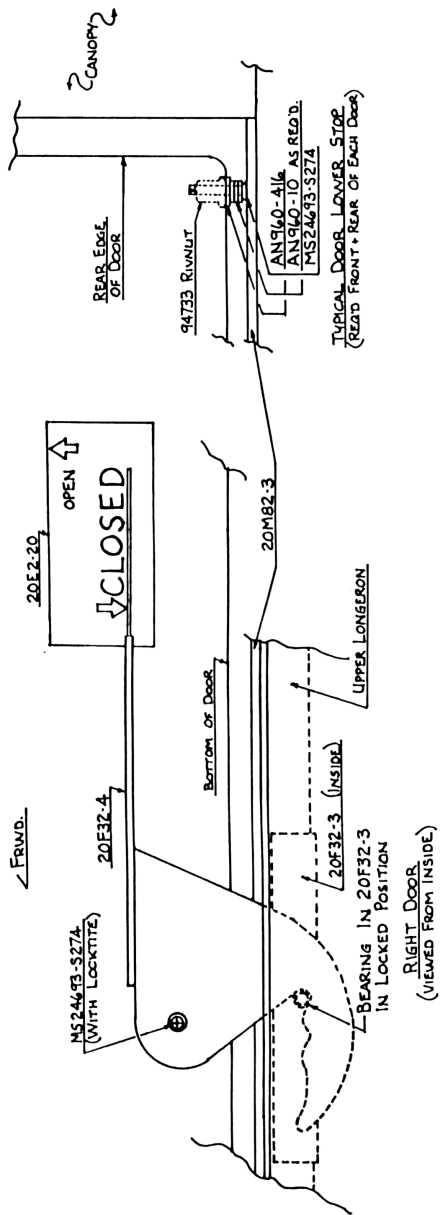
“Gull wing door” handle area inspection, as per schematic on page two of this Service Letter.

- Install label 20-E-2-20 as per following schematic (on page two), as follows: From inside the aircraft, with the “gull wing doors” closed, make sure that the door handle is parallel with the arm rest. Glue label 20-E-2-20 with the “closed line”, lined up with the handle. Note that there is a left and right label.

- Inspect the bearing in 20-F-32-3 and make sure that it is not worn-through, that it rotates freely and that it is greased.
- The schematic shows a 10-32 rivnut located front + rear of each door, with washers and countersunk screw. When the door handle is in the closed position, the front + rear countersunk screws must be tight against 20-M-82-3 (channel on top of Upper Longeron).

- Make sure that the door handle position is as per schematic in the “closed” position and that it has “positive locking pressure”.
- Make sure that handle screw MS24693-S274 is tight and that “locktite” has been applied.
