October 15, 2001

Dear STOL builder:

STOL
701/801

TOP CHANNEL ZEE REINFORCEMENT

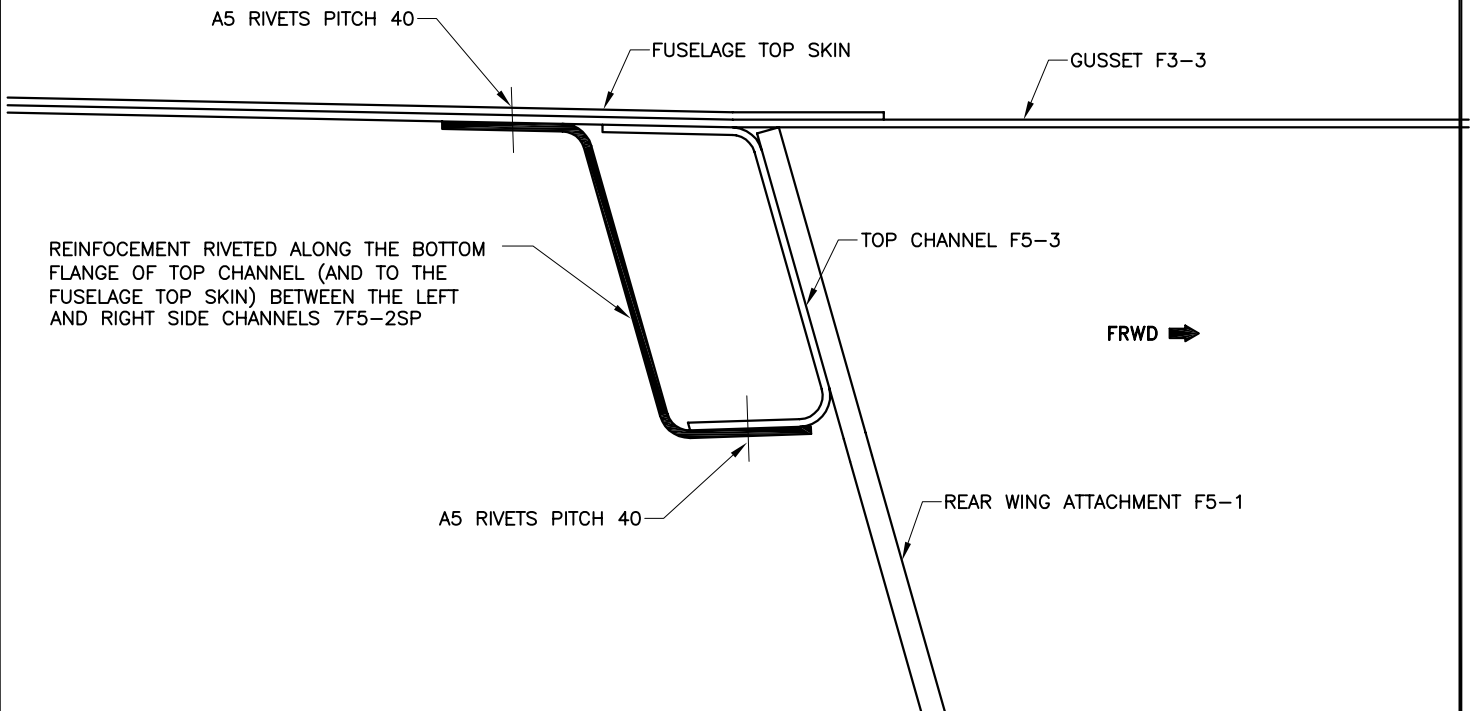
F5-3Z

For those of you who may be operating the aircraft in excess of the published VNE and/or at weights higher than the published gross weight figures (you know who you are!), I recommend that the Top Channel be reinforced (see following drawing F5-3Z). Two such aircraft have been reported to have shown signs of buckling along the middle portion of the Top Channel.

While this change is not a required for those of you operating the aircraft in "normal" conditions, I would suggest you inspect the part for any signs of deformations. For those of you using the aircraft in "utility" applications, I suggest reinforcement of the doubler.
