## **MANDATORY ACTION – SAFETY ALERT**

CH 601 and CH 650 series canopy secondary latch installation required.

All low wing (CH 601 and CH 650 series) models with bubble canopies.

### COMPULSORY FITMENT OF A SECONDARY CANOPY LOCKING DEVICE, ON ZODIAC/ZENAIR/ZENITH AIRCRAFT CANOPY

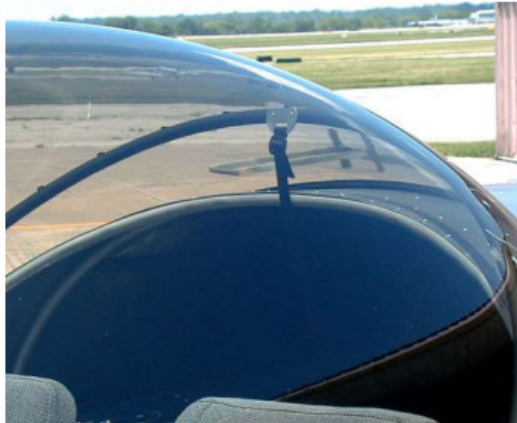
***Figure 1 above: a simple strap type secondary canopy lock.***

1. Manufacture and fit a secondary locking mechanism to the canopy, which has the capacity for 'quick release' in case of an emergency. An example is given in Fig 1 below.

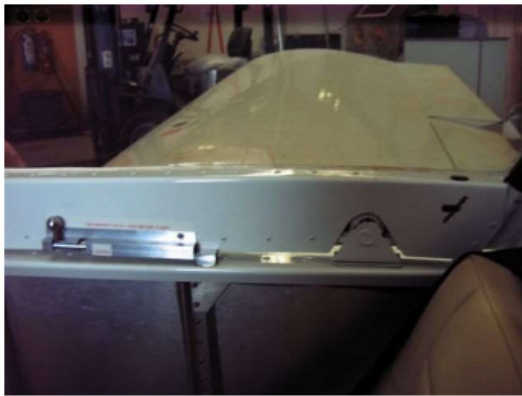
***Figure 2 above: a simple barrel latch fitted on both sides of the canopy.***

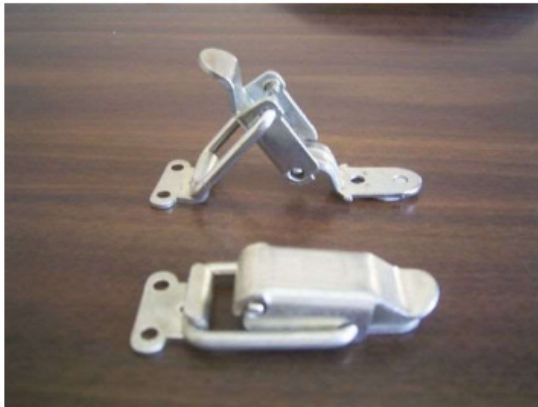
***Figure 3 above: Another type of quick release latch which could be fitted to each side of the canopy.***

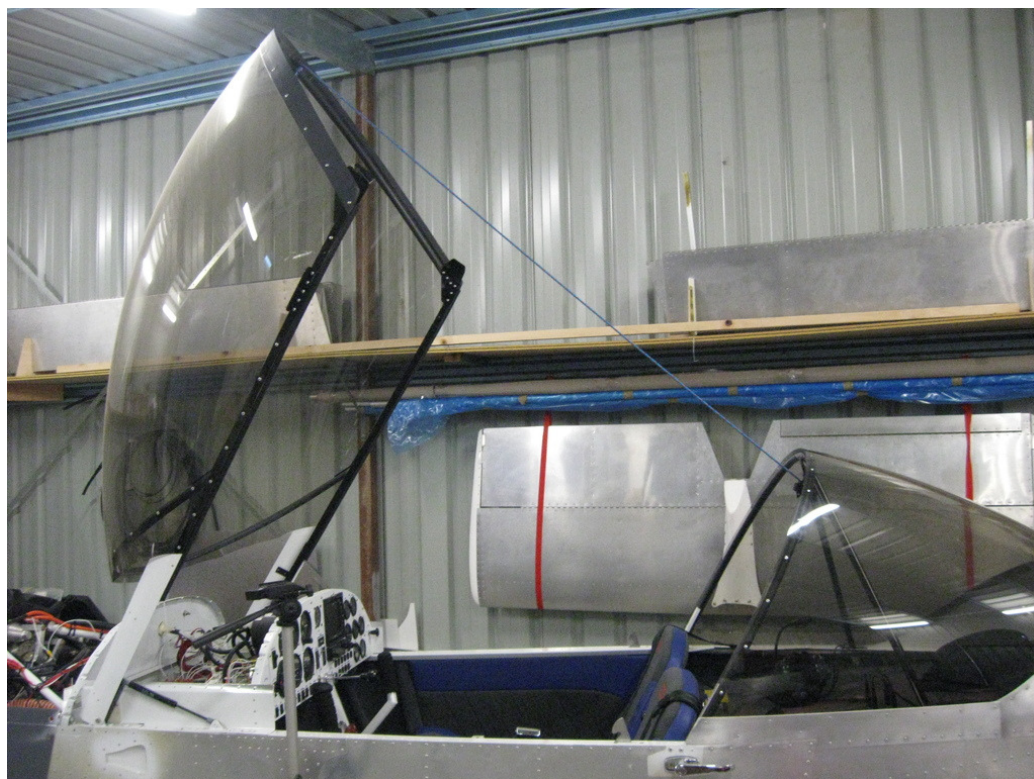
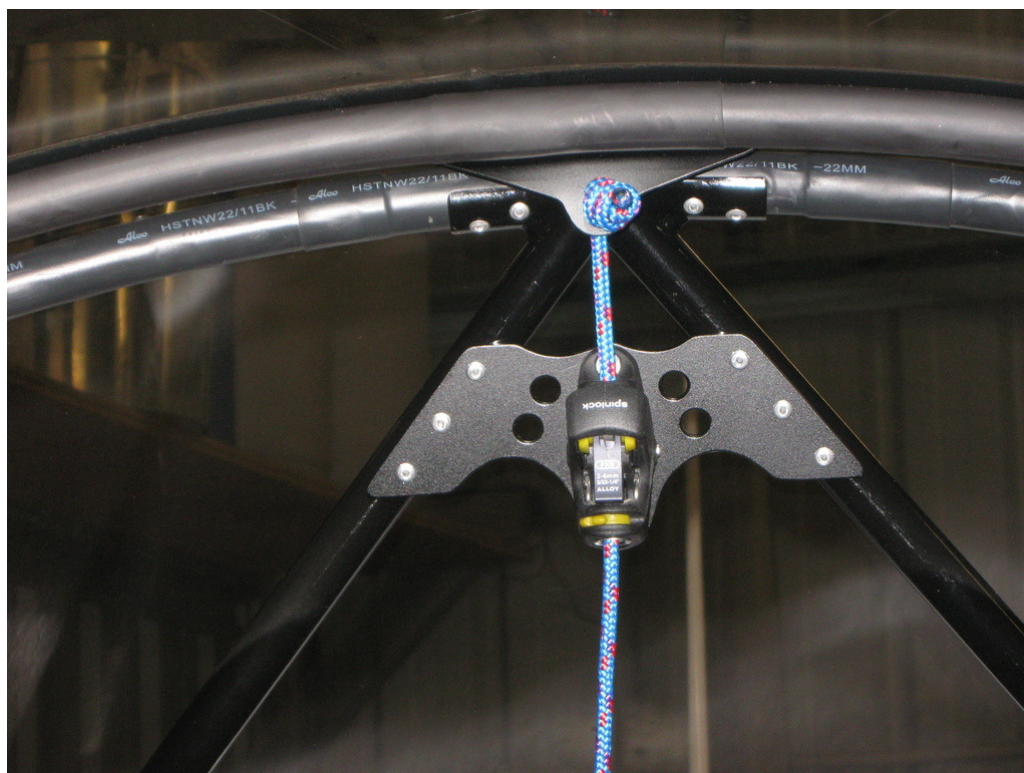
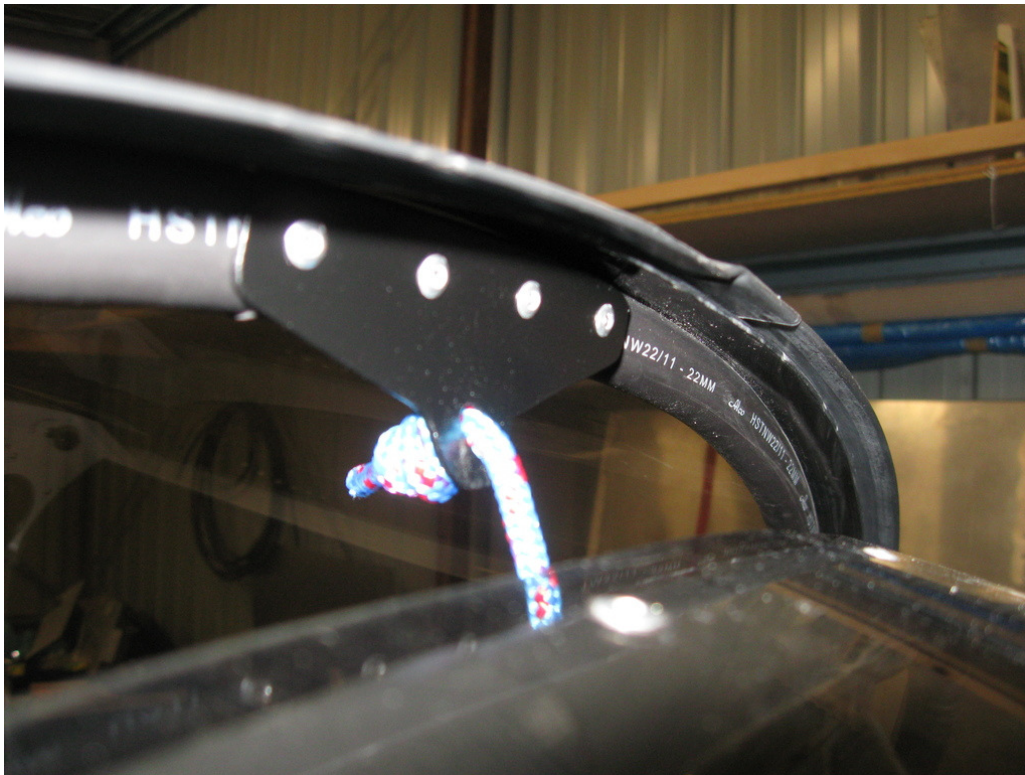
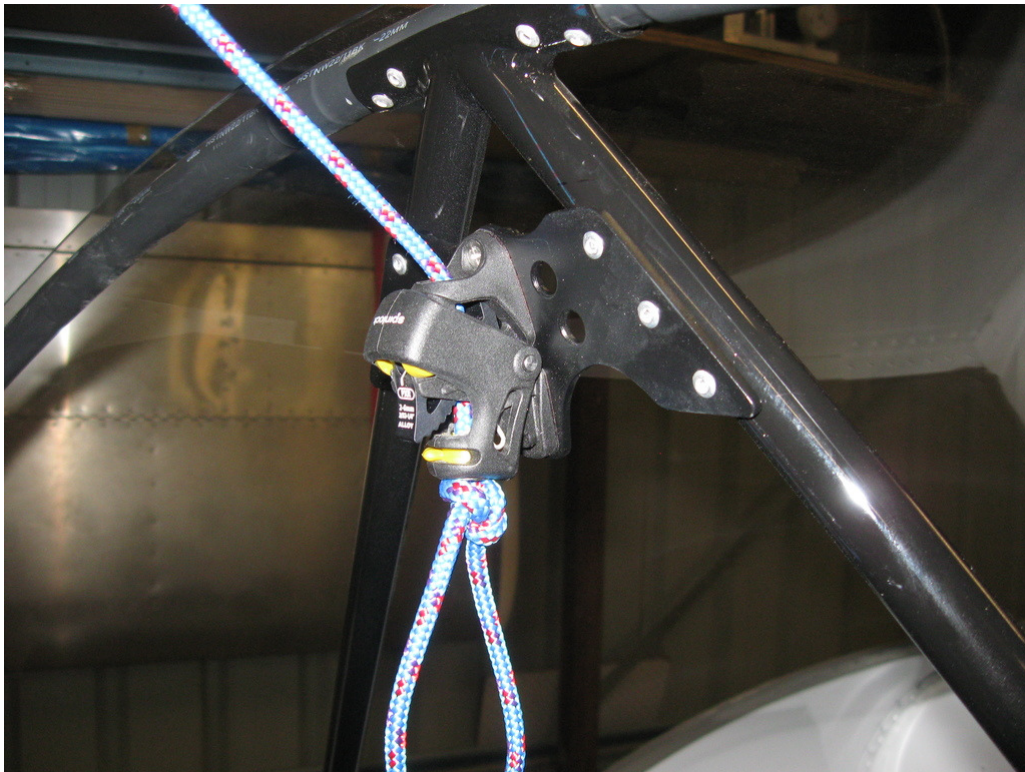
“A secondary latch is mandatory in Australia. Here is what I did using a sailing boat rope cleat. It's model is a Spinlock PXR0206 and a 6mm rope. Flick the rope firmly rearward to lock and forward to release”.
