Aircraft Manufacturing & Design LLC
Heart of Georgia Regional Airport
441 Airport Road, Eastman Georgia 31023 USA
www.newplane.com
TEL: (478) 374-2-SKY FAX:(478) 374-2793

# **NOTIFICATION**

Securing control surfaces when aircraft is parked

All AMD models

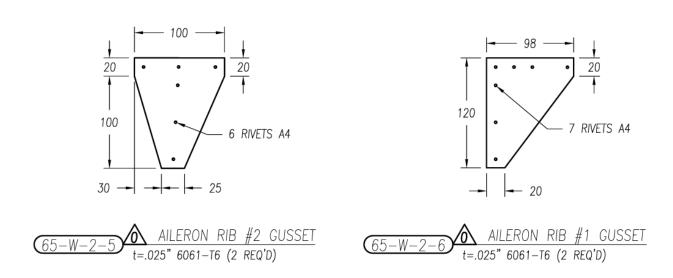
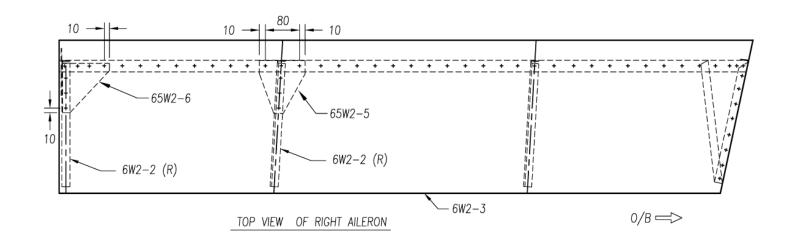
## SUPPLEMENTARY AILERON GUSSETS

Aircraft are designed to meet moving air masses head—on. When tied—down outside rather than inside a hangar, an aircraft can be subjected to strong winds from any direction. Zenair has received reports of small unseemly kinks in the aileron skin near the inboard hinge area, presumably caused while the aircraft was parked outside without a control lock in place; installation of this gusset is recommended to reduce the risk of potential damage to the area. These gussets are recommended for the Zodiac CH601XL and are included standard on the Zodiac CH650. See the drawing below for details.

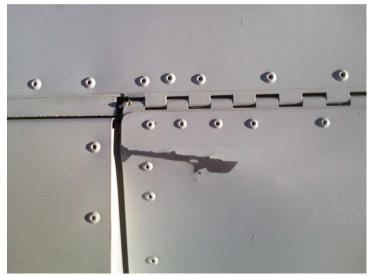
"The aileron damage [see photos below] occurred while the plane was tied down on the ramp. Winds were 30MPH gusting to 50MPH straight against the tail. I had the seat belt around the control stick with another strap wrapped one time around the stick in the opposite direction connected to each rudder pedal. All was secure when I left the plane but the seat belt appeared to slip some in the adjustment as well as the rudder and pedals ended up at full deflection over the duration of the wind."

Photos supplied by customer who confirmed that damage was due to high winds when aircraft was tied-down outside without controls adequately locked.

Above – Top of aileron damage

Inspect your control system, specifically the ailerons. Also see AMD Safety Alert of October 29, 2008. Only proceed with operation of the aircraft when control systems show no excessive wear, tear or damage. Caution: Some damage can be missed if inspections are cursory; careful inspections are the best way to insure the aircraft is airworthy.

- a) If there is any deformation at the ailerons, please contact AMD immediately. Do not fly the aircraft until a certified mechanic has fixed the problem and has signed off the aircraft in the airframe log book.
- b) Installation of supplementary aileron gussets as per page 3 of this NOTIFICATION is recommended for aircraft kept outside. Part numbers 65-W-2-5 and 65-W-2-6.
- c) Controls can be secured and/or locked by attaching the seatbelts tightly around the control stick and/or by using control stops similar to those shown on photos below (see page 4). When high winds are expected, rudder pedals should also be secured/locked. Controls should always be secured/locked when the aircraft is parked outdoors.
- d) Remember to remove all control stops before flying (add this step to your pre-flight walk-around checklist).

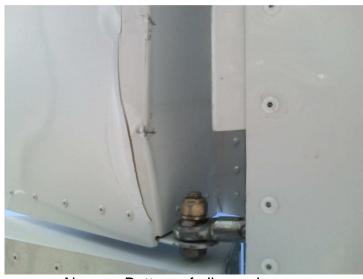
Above – Bottom of aileron damage

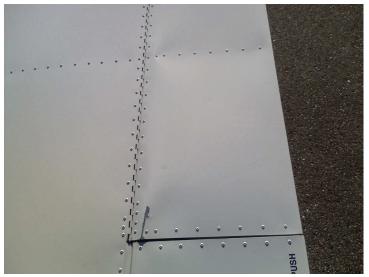
Above – Top of aileron damage

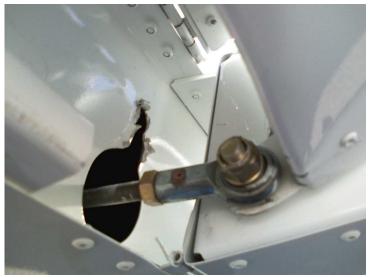
Above – Rear spar damage
