SAFETY ALERT / SAFETY DIRECTIVE

Upgrading the bellcrank control system of the STOL CH 750.

Factory built AMD SLSA CH 750 STOL, all serial numbers.

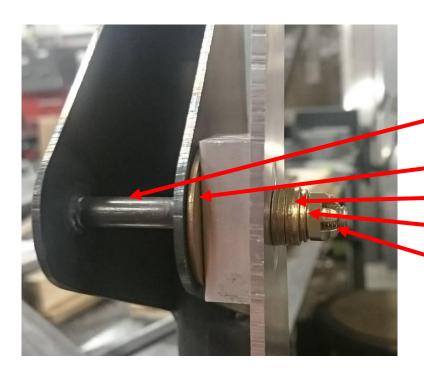
Updating the bellcrank control tube with an AN4 bolt through the existing tube.

Existing bellcrank connection

New bellcrank connection

Drill inside the 5/16" welded tube for an AN4-26 bolt.

AN4-26 bolt through the existing welded tube.

1 penny washer 5/16"

4 washers 5/16" or as required

1 washer 1/4"

1 Castle nut with cotter pin

Completed assembly needs to be snug and free of sloppiness but easy to rotate.

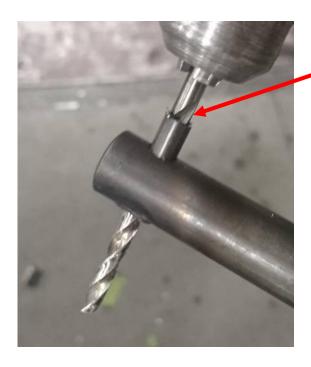
Updating the Elevator control tube with an AN3 bolt through the existing tube.

Drill inside the ¼" steel welded tube for an AN3-15 bolt. Use an AN3-13 bolt if steel tube is cut shorter (as shown).

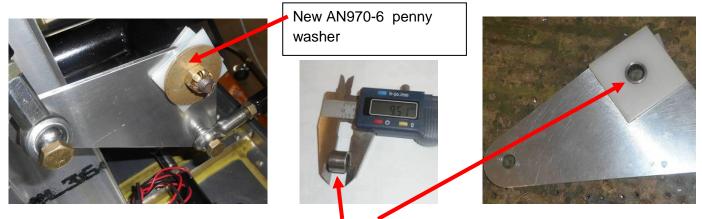
Aileron Bellcranks

When holding the control stick tight in the cabin, have someone move the flaperons up and down. There should be no floppiness in the aileron bellcranks. The complete control system must be tight and free of play (same with elevator and rudder).

If the flaperon bellcranks are floppy, check that the bushings are not too long. If necessary, file down the bushings. Replace the existing washer under the castle nut with an AN970 penny washer.
