## **SERVICE LETTER / NOTIFICATION - May 30, 2018**

Inspection of the main gear spring attachment points.

All Chris Heintz (CH) aircraft with a one-piece main gear spring

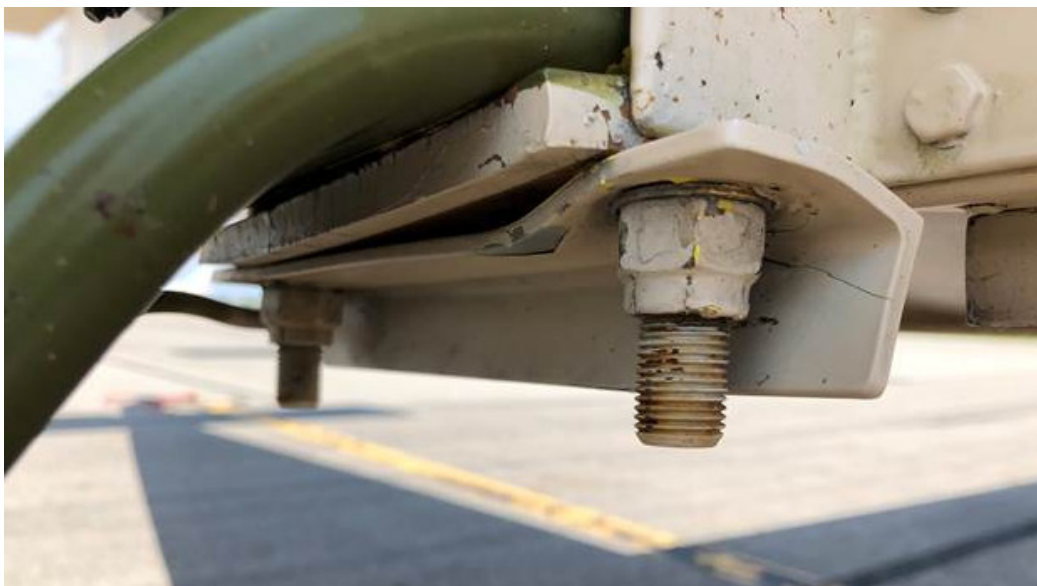
Inspection of the main gear area. Over-tightening of the gear bolts or extreme hard landings could lead to bending of the bottom extrusion. Additionally, if the gear is loose, bending of the extrusion could happen.

Inspect for deformation of the extrusion holding up the main gear spring.

Inspect the rubber pads, make sure they are in good condition and tightly fitted to the gear; that you cannot move them.

Inspect the general condition of the gear spring attachment area. Also inspect the steel parts and bolts/nuts for proper installation, possible deformation, corrosion, etc. Repair or replace parts as necessary.

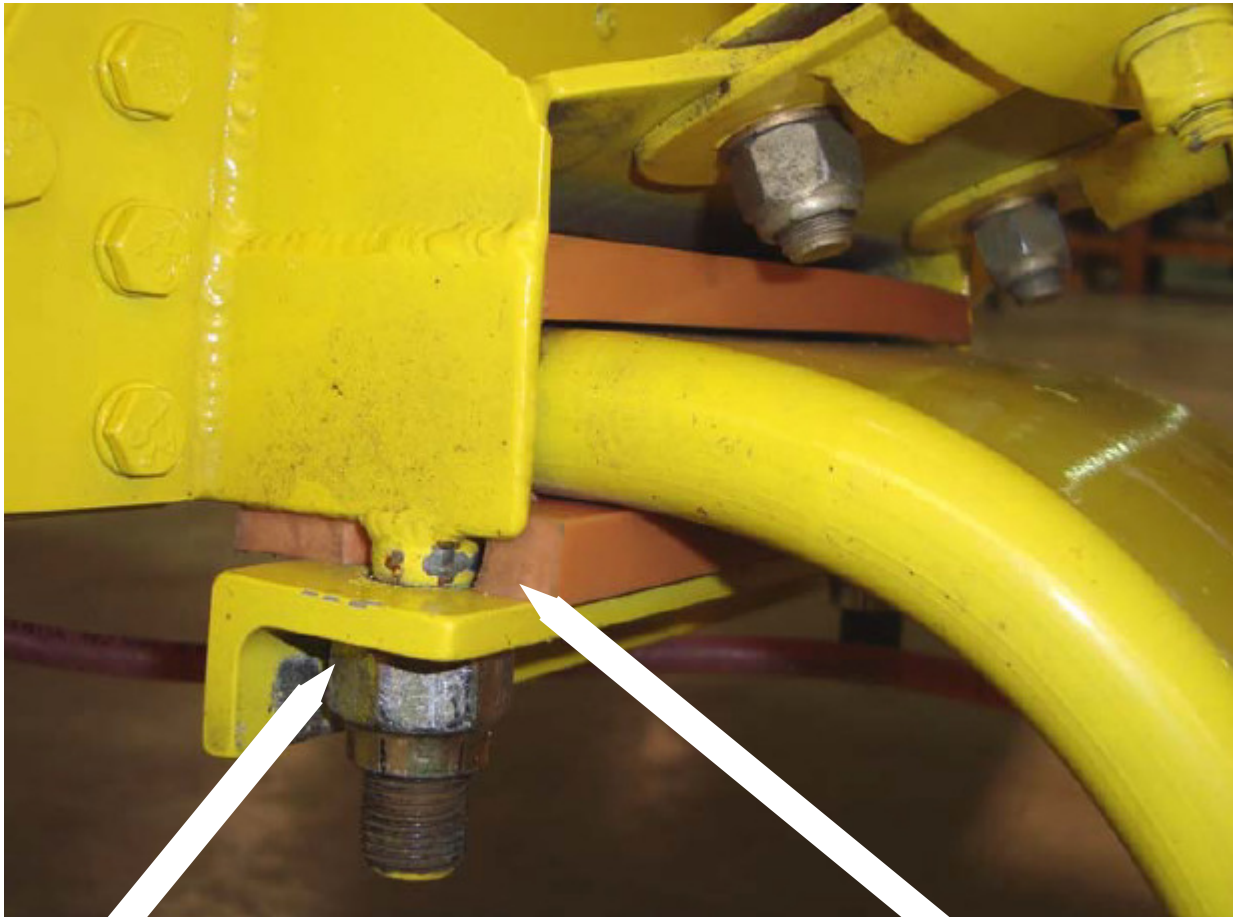
Notice: Required gap between extrusion and welded gear support assembly.

When tightening the gear bolts, do not over tighten as the extrusion will bend. A snug fit is recommended or a torque of about 110 LB. IN. (CH750 series) But most important is to not start bending the extrusion. The torque value is not accurate and could be different for the different models and installations.

Install a washer on the stud under the lock-nut and tighten the nut. Nuts should be tight but should not bottom-out on the bolt shanks (shoulders).
