**ZENAIR LTD, HURONIA AIRPORT, MIDLAND, ONTARIO, CANADA L4R 4K8
TEL:(705) 526-2871 - FAX:(705)526-8022**

SERVICE LETTER / NOTIFICATION – FEB 13, 2023

Upgrade your rudder pedals 7C4-1J

CH 701 STOL

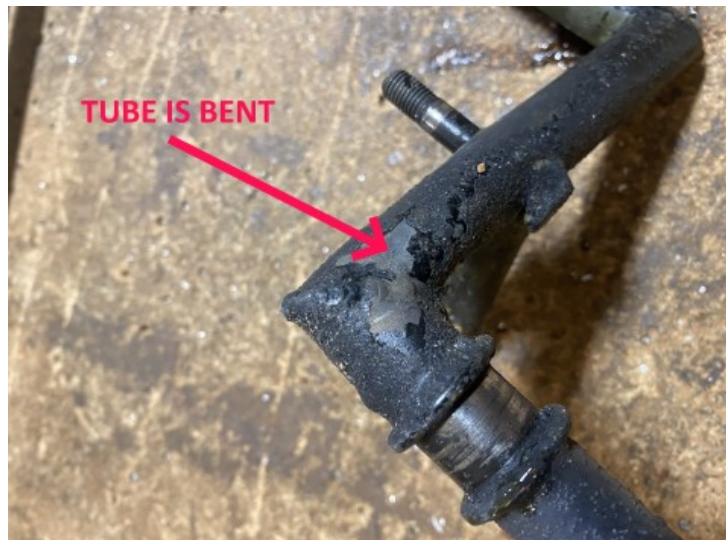
A 701 customer noticed the rudder pedals 7C4-1J had a bend in the bottom corner. After removing the pedals he noticed the wall thickness on the tubing was 0.035” instead of 0.058”.

If your rudder pedals were manufactured with the 0.035” tube thickness, you need to upgrade your pedals to the 0.058” tube thickness.

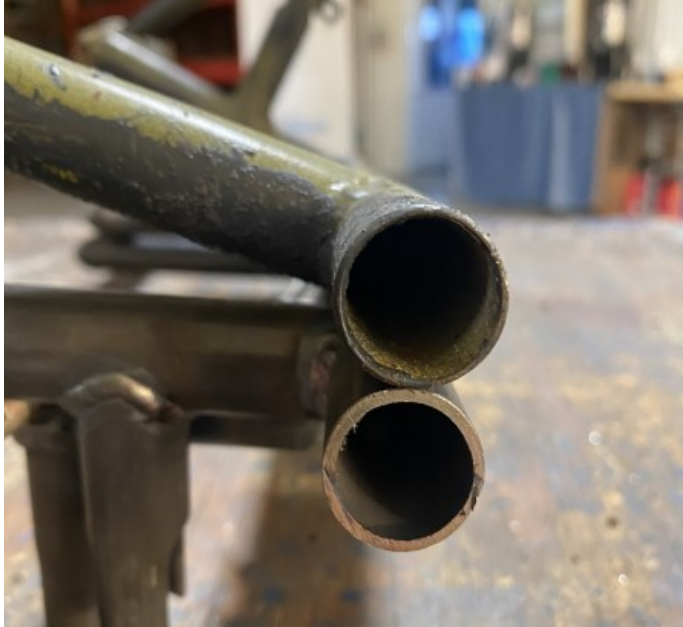
The bottom tube in the photo is thicker at 0.058”. This is the correct tube type. Pedals with thinner tube must to be changed to avoid bending or possible cracking.

Inspect your rudder pedals. Check the tube thickness.
