NOTIFICATION - Jan 08 2020

Door upgrade

Chris Heintz (CH) STOL and CRUZER CH750

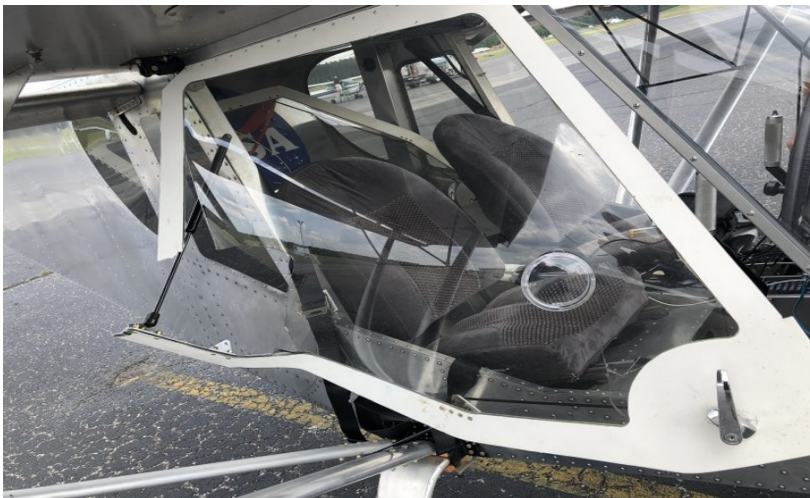
The original STOL CH750 SLSA uses a fibreglass framed door systems for pilot and co-pilot. There continues to be reports of doors cracking in flight on the STOL and Cruiser CH750's.

Photo shows a broken fibreglass door frame.

If your door opens or cracks in flight, slow the aircraft speed and continue to fly the aircraft to the nearest safe landing. Do not hold onto the door. Fly the aircraft.

Aircraft owners are encouraged to upgrading to the latest door design within the next 25 hours or sooner if cracks or damage is noticed or if the doors do not close properly.

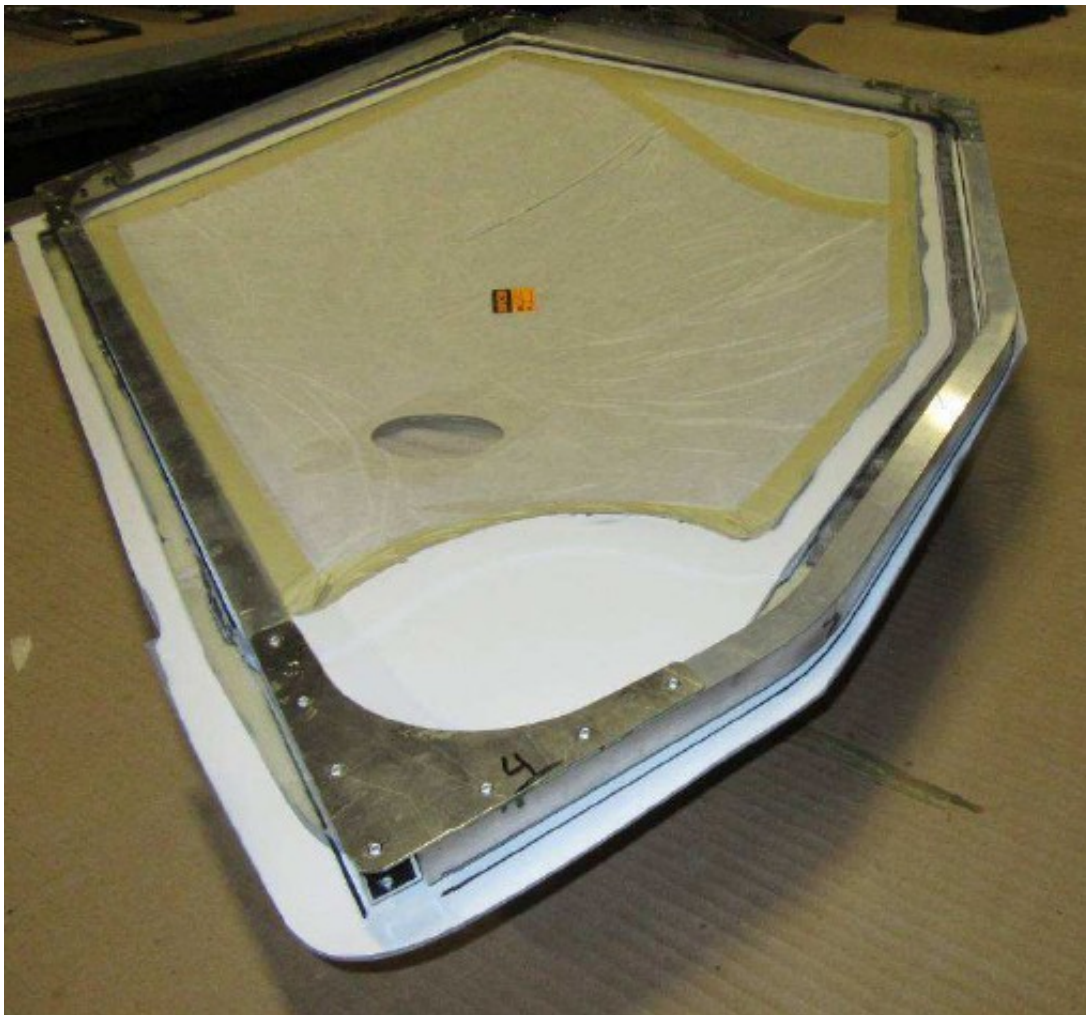
Old style fiberglass door with new aluminum frame on top

Or you can modify your existing fiberglass doors by adding the aluminum frames and new latch/handle system.

When keeping the fiberglass doors and adding the aluminum frame, also view pages 8 and 9 of photo guide C75-NA-1 Section 4 . Upgrade the door frames and everything else as per the STOL CH750 drawings, revision 4. Pages 75-N-1, 75-N-2 and 75-NA-1 and 65-NA-2. Use the Zenair drawings, the photo guides and the Zenair Construction Standards Manual and or FAA 43.13-2A (Aircraft Inspection and Repair).
