NOTIFICATION - JAN 15 2020

Elevator Stop

Chris Heintz (CH) CRUZER CH750

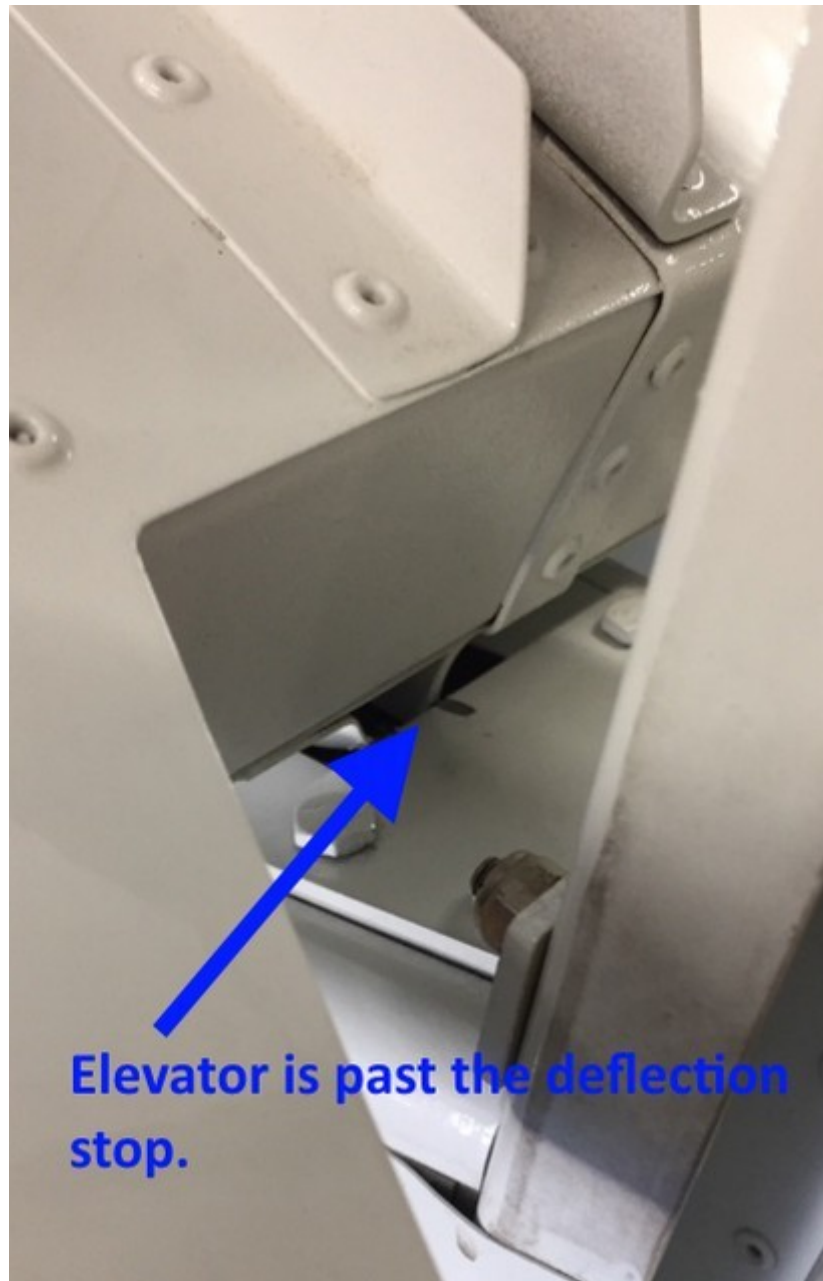
We were parked at the fuel pumps when a Blackhawk helicopter flew by slowly along the runway (200ft? away). The rotor wash hit us briefly and slammed the elevator down and beyond the stop. We want to make sure that this can never happen again and are thinking we would add a piece in front of the bracket so that the horn can no longer slip past the stop.

The following photo of the elevator horn that has slipped slip past the stop.

One reason for the stop not being long enough is that the positioning of the Stabilizer to the fuselage can vary when installing. So if the Stabilizer is a bit forward, the elevator horn will have less contact on the fuselage stop.

Inspect all your aircraft deflection stops and deflections. Use the drawings for proper deflections and positive stopping.

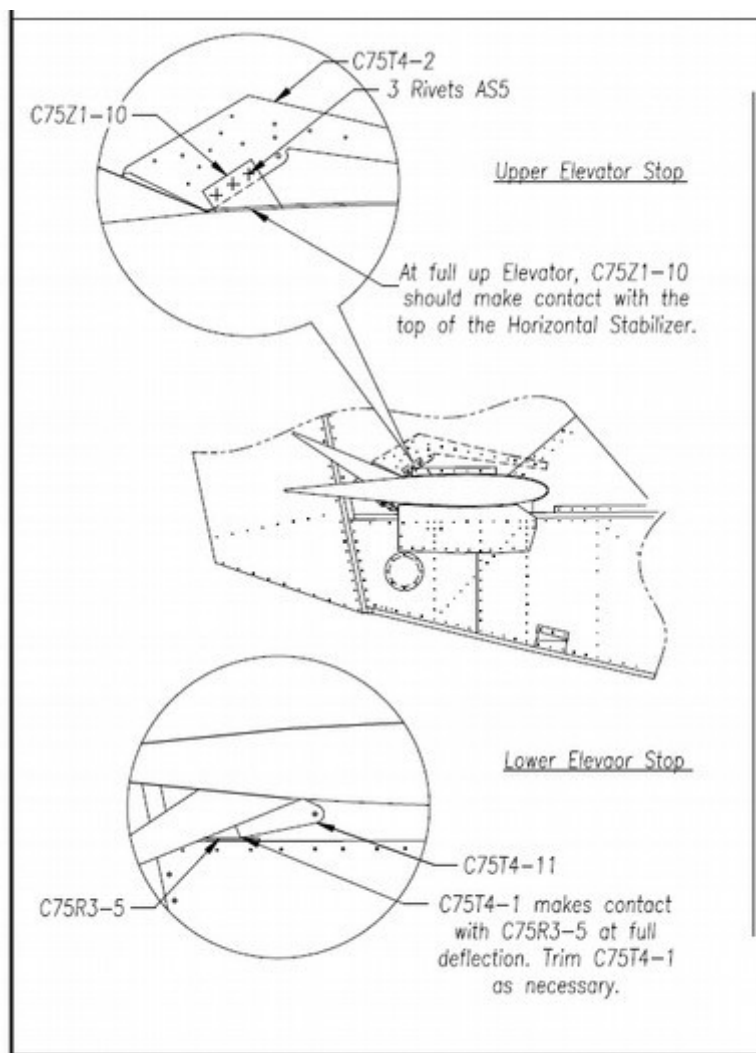
Above Cruiser drawing C75-ZA-6

This drawing shows that C75T4-1 (horn) makes good contact with C75R3-5 (stop) at full deflection. In the event that the contact is marginal and with some force can go past the stop, an extra stop needs to be added.
