SERVICE LETTER / NOTIFICATION - AUGUST 2017

Rudder Inspection.

CH 701 rudder inspection.

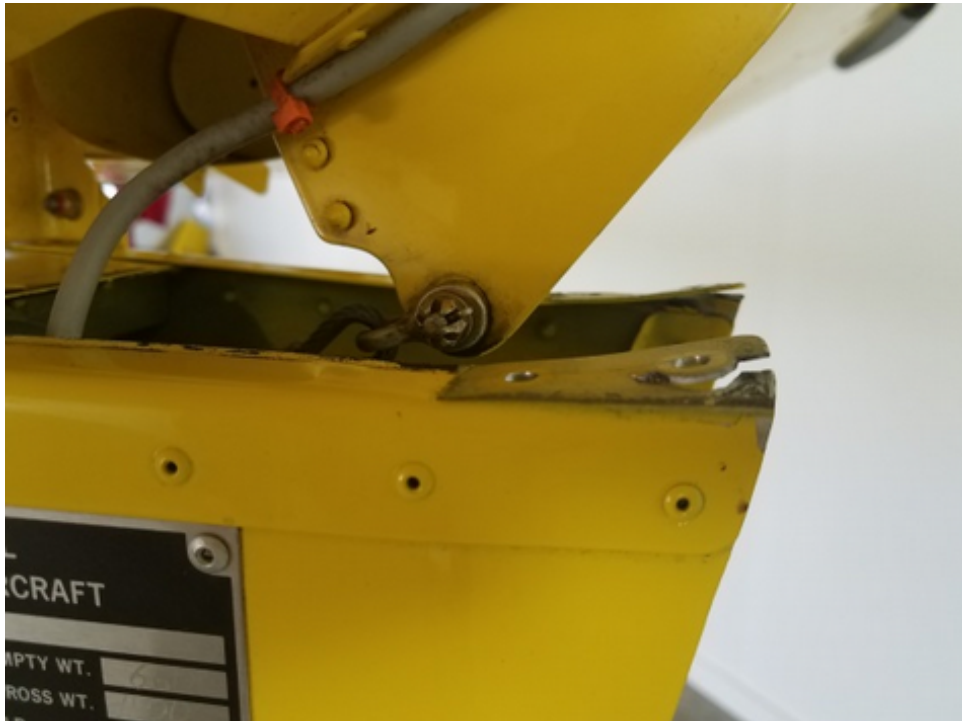
A CH 701 was inspected and the following was noticed; rudder top hinge area was damaged.

Damaged near the top hinge, easy to see after removing the top hinge bracket. When taking off or landing at an extreme angle, it is possible that the rudder can hit the ground damaging the bottom of the rudder but also the areas on the fuselage near the hinges.

Add new longeron doublers as per following photo. Use the FAA AC 43-13 1B and 2B manual and the aircraft drawings and design standards manual for proper material rivets etc. Use a 6061-T6 aluminum angle with 0.040" thickness. Rivet this on top of the existing parts. If rivet holes are oversized, add extra rivets between. If the fuselage side skins are damaged, replace the damaged area by following the instructions in AC 43-13-1B section 4-58, or replace the skins. Once the rudder is re-installed, have an aircraft mechanic inspect the area, control system and cables for proper cable tension, attachment etc.
