SERVICE LETTER / NOTIFICATION – OCT 03, 2022

Hardware Inspection

All aircraft - CH designs

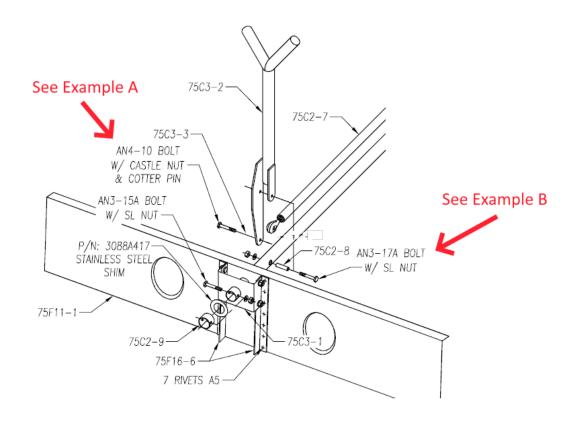
A standard non aviation nut was installed onto the bolt holding the pilots elevator bellcrank system. On take-off, the bolt slipped out and the pilot was left with no elevator controls.

WRONG NUT USED

BOLT FELL OF THE Y STICK

Inspect all the bolts and nuts on the aircraft.

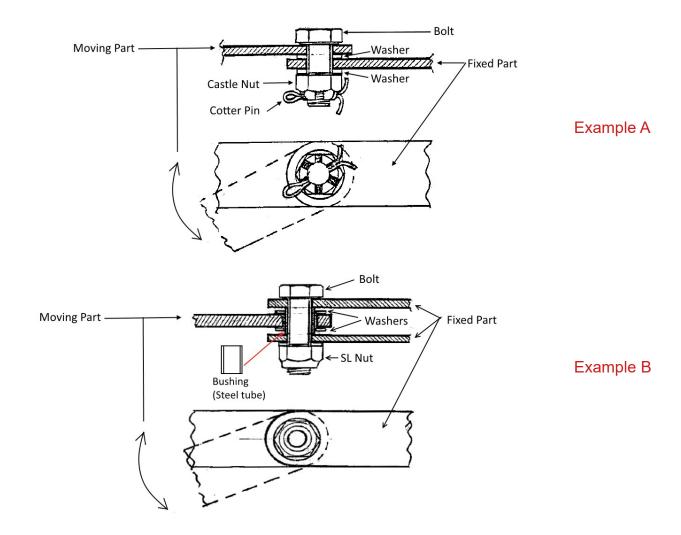
Drawing showing the proper fasteners

There are 2 types of rotating bolt/bushing installations in a typical CH design. For the control Y stick installation, both are used.

When a part is moving around the bolt, a castle nut is used on the bolt as the bolt can rotate (Example A).

When the part is rotating around a bushing, the bolt is tightened to the bushing so the bolt does not rotate. An SL (Self Locking) nut is used (Example B).

Note that in both cased, the part must be able to rotate freely and smooth with minimum play so that the controls are smooth throughout.

When inspecting, use the aircraft Design Standards manual, aircraft blue prints, and FAR 43.13-1B & 2B if required.
