NOTIFICATION - OCTOBER 03 2018

Elevator Piano Hinge and Stabilizer update

CH 750 Cruiser

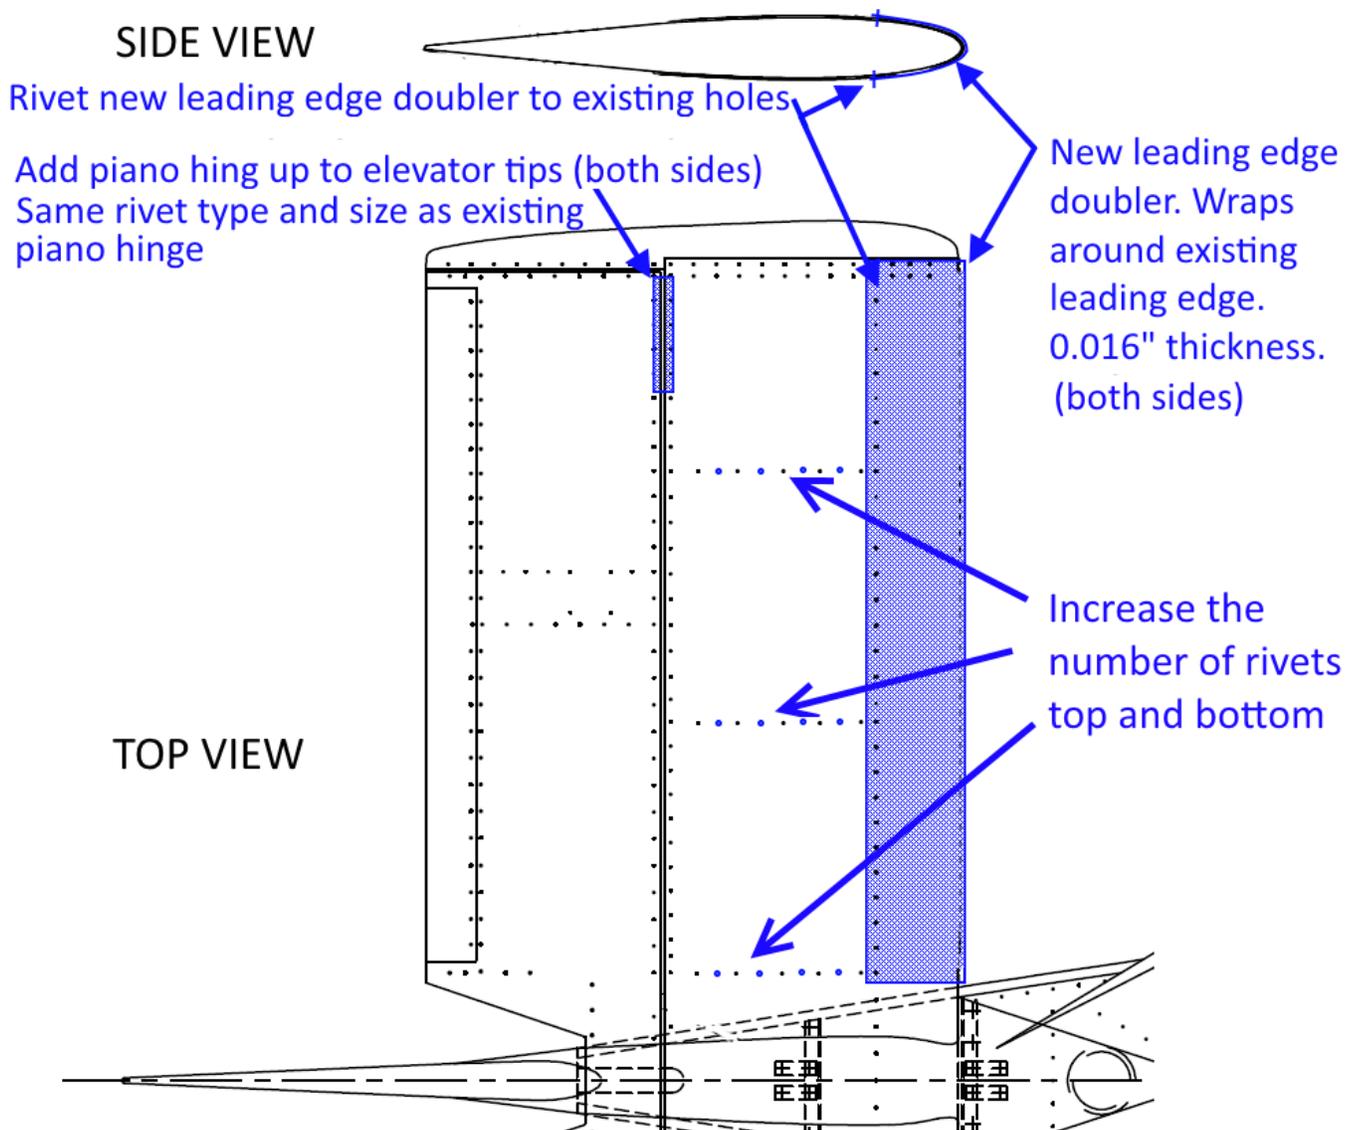
A CH 750 Cruiser owner reported significant dents and cracks occurred on the leading edge of the horizontal stabilizer near the tip. The aircraft was equipped with the high compression ULPower UL350iS engine which produces more thrust and possibly more vibrations / harmonics (than the less-powerful engine installed on the Zenair demonstrator aircraft).

2, For aircraft with more power than the typical 100HP of the Rotax 912 or Continental O-200 or for aircraft with an elevator skin of 0.016" thickness, add an aluminum leading edge doubler (0.016" or greater) on top of the existing leading edge of the stabilizer over the full span. There is no need to remove the stabilizer from the aircraft.

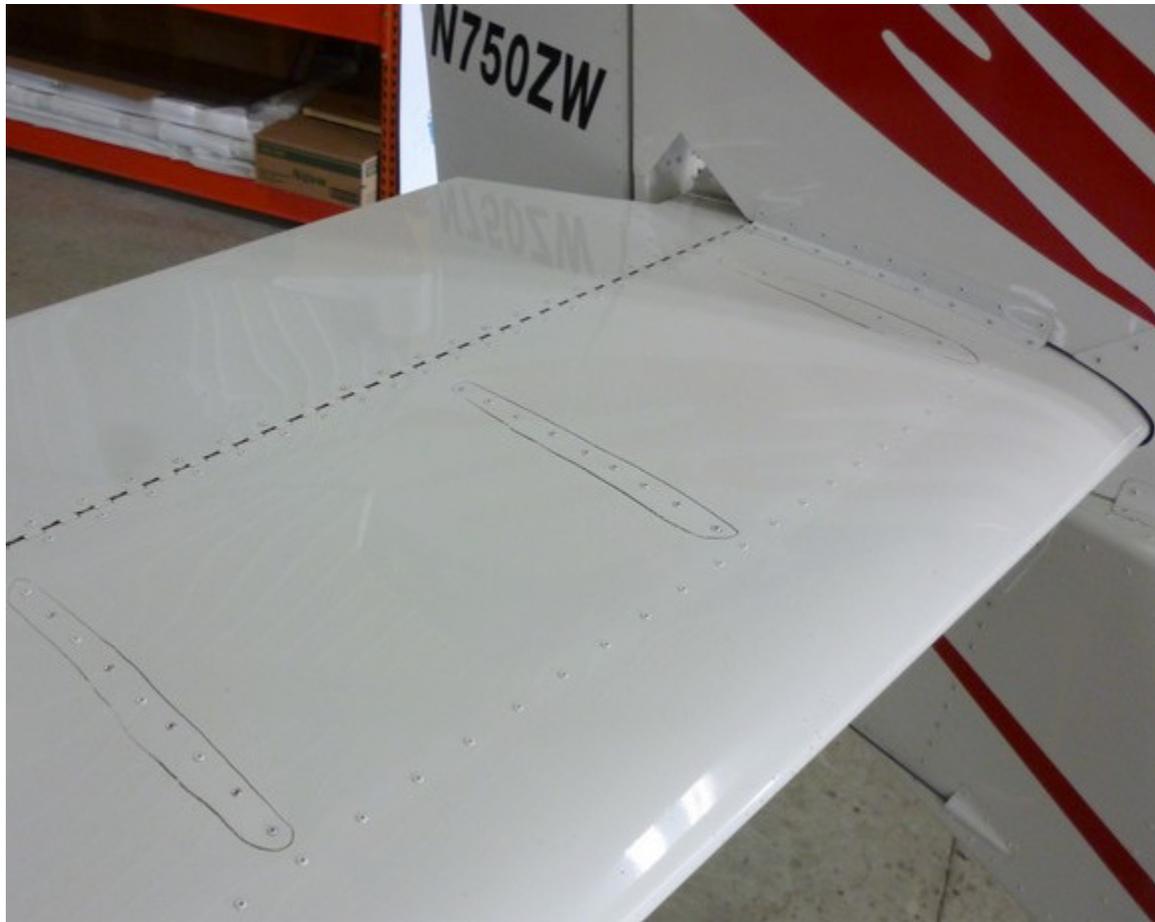
Rivets have been doubled up in the above photo on ribs centre ribs C75T1-2 and C75T1-3.

3. On Ribs C75T1-2, C75T1-3 the rivet spacing needs to be decreased from 60mm to about 30mm, which will increase the number of rivets between the front and rear spar. On those ribs there needs to be a total of 9 A4 rivets per side as shown in the above photo. Top and bottom.
