SERVICE LETTER / NOTIFICATION - JAN 10, 2018

Inspection of “L” angles in the rear fuselage

CH750 – STOL/Cruzer

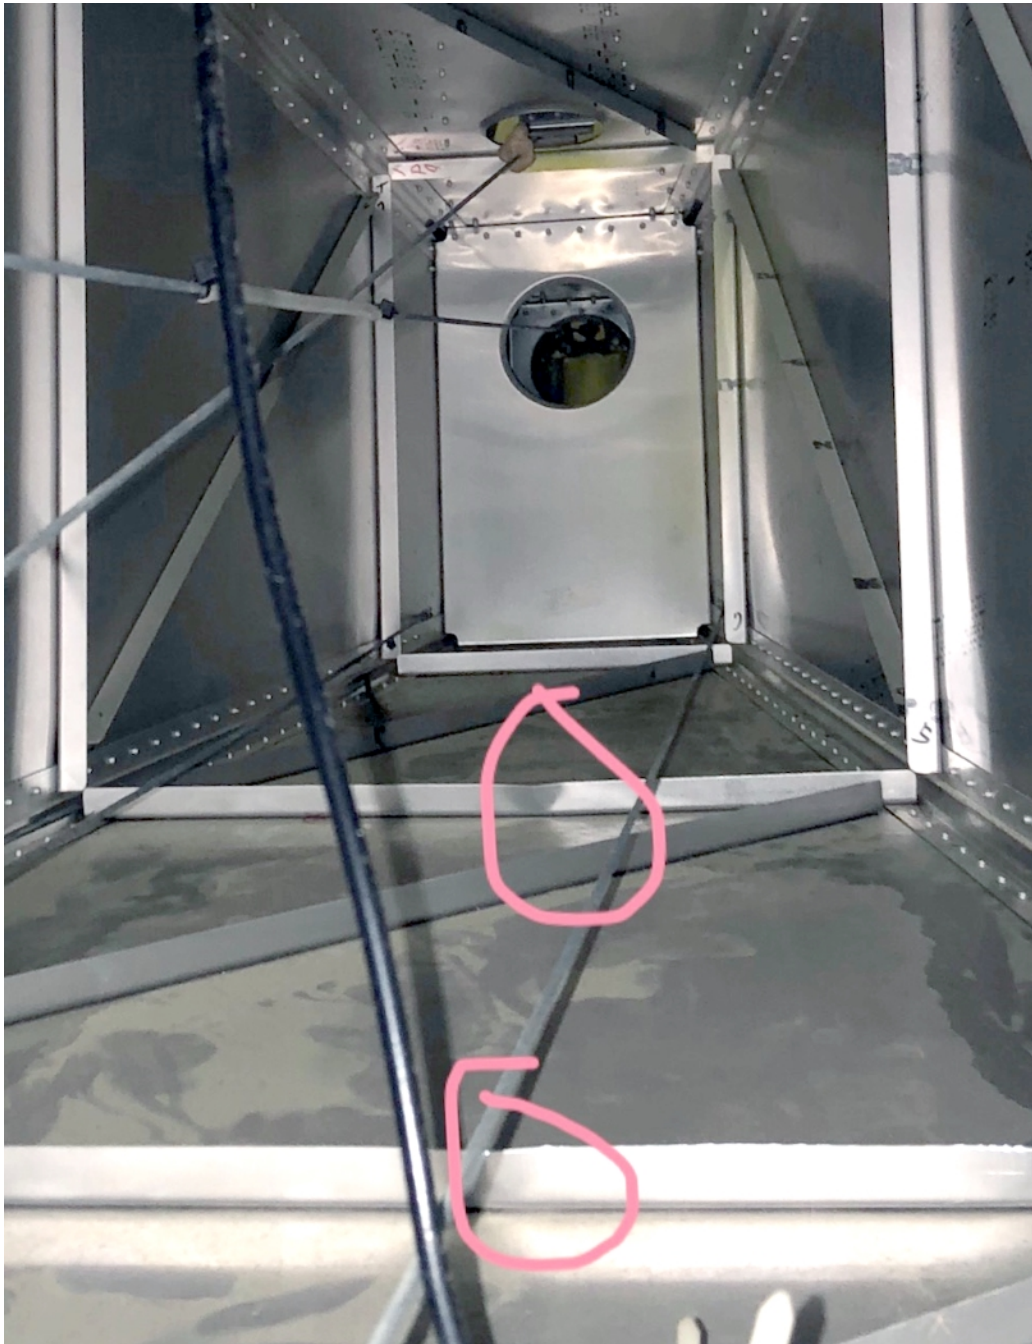
A CH 750 Cruzer was inspected and the following was noticed; “L” angles in the rear fuselage floor were cracked and bent

Above photo shows the cracked and bent "L" angles.

Remove all damaged "L" angles or other parts that are bent or cracked and replace. Refer to manuals and/or Best Practices.

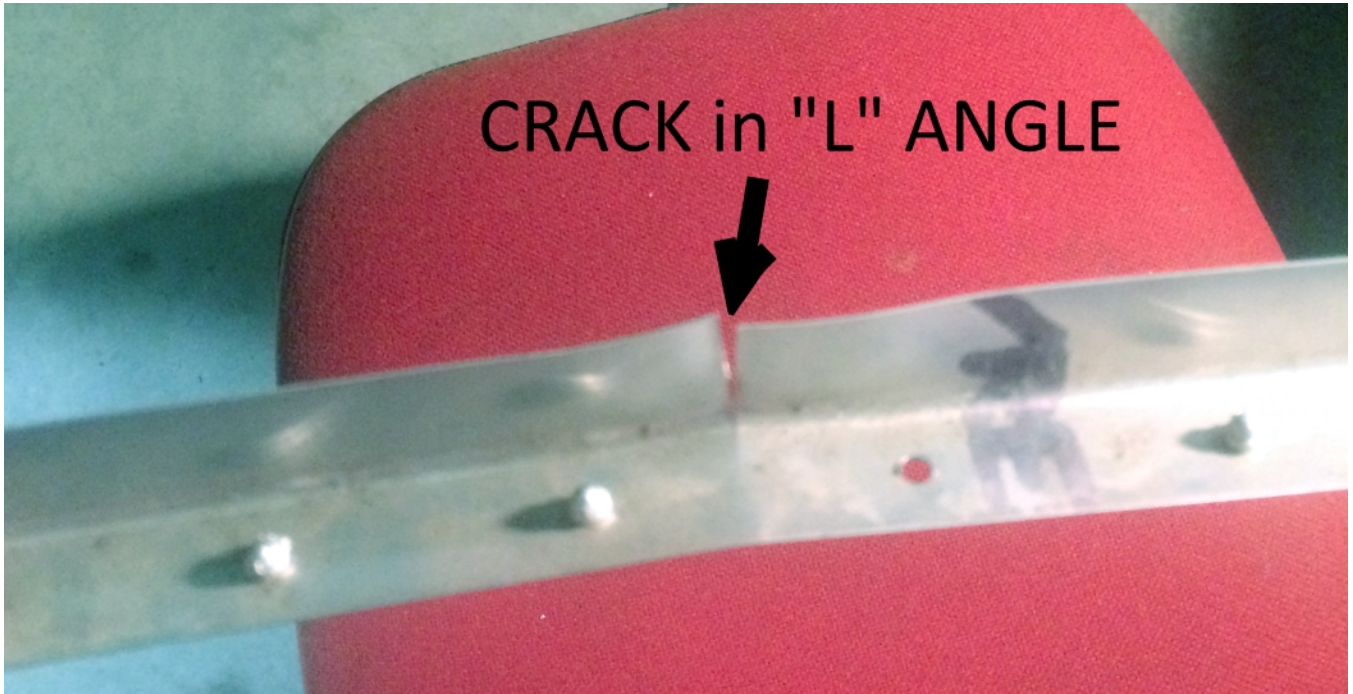
Photo of the cracked "L" angle after removal from the aircraft.
