## **SERVICE LETTER / NOTIFICATION – OCT 22, 2024**

Seat back tube inspection and reinforcement

CH 750 – STOL / CRUZER / SD

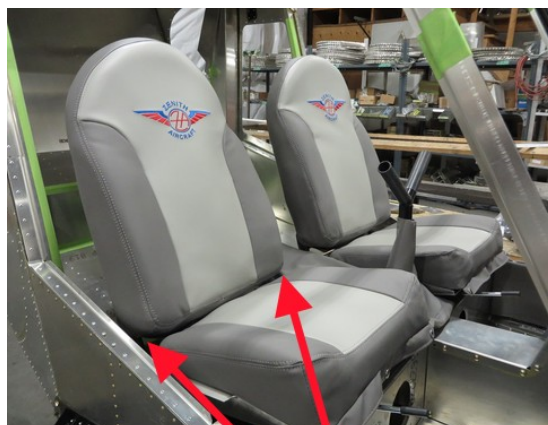
Some seat back steel tubs (C75F13-4) at the bottom have shown signs of damage. Applying an excessive amount of braking force will result in a huge amount of pressure on the seat back, and this can damage the tube.

Seatback tube damage

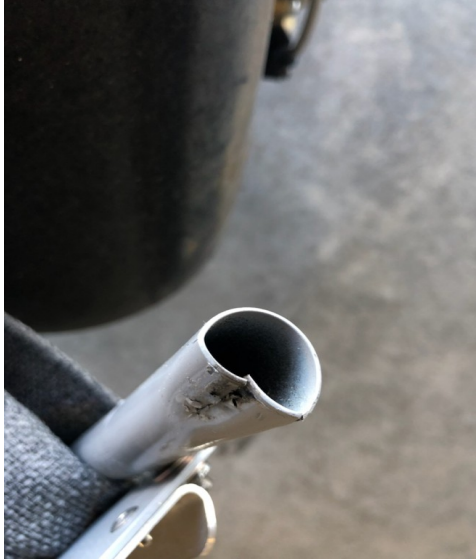
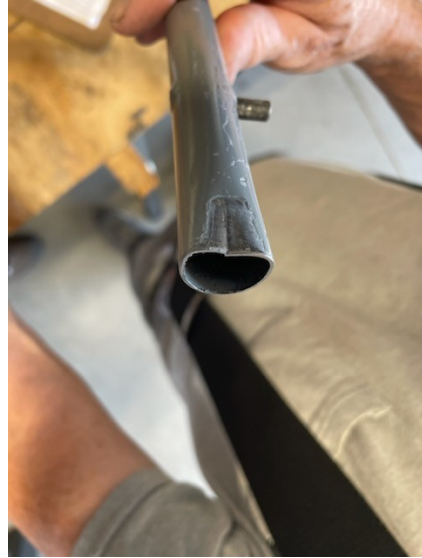
Typical damaged seat back tube, at the bottom.
