## **SERVICE BULLETIN NO. 00-04**

This Service Bulletin defines the requirements to perform a one-time visual inspection for the purpose of locating cracks in the firewall (part A), install repairs on cracked firewall area (part B), and strengthen the engine cowl strip retention (part C).

The affected models are aircraft CH 2000 serial numbers 20-002 to 20-0047

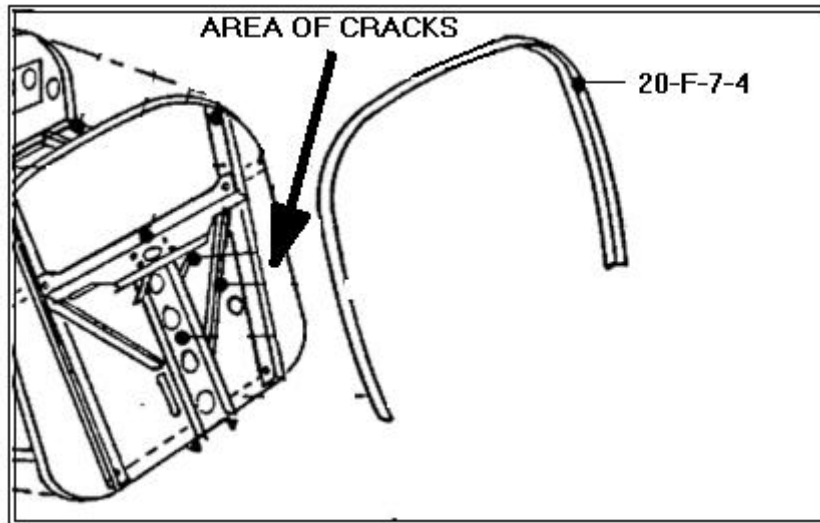
Fig. 1

Visually inspect the firewall, from the inside of the cabin, for cracks originating from the fastener holes for the rivets securing the engine cowl strip P/N 20-F-7-4 to the left-hand and right-hand firewall sides. Refer to Fig. 1. If cracks are found, perform Part B of this Bulletin

1. Remove the stainless steel rivets securing the cowl strip to the firewall, in the area of the cracks.
2. Move and retain the detached portion of the cowl strip away from the firewall in preparation for stop-drilling the ends of the cracks.

3. Stop-drill the cracks by using a #40 (2.5mm) drill bit to make holes at the ends of the cracks (crack tips) from inside the cabin.
4. From the galvanized steel material, manufacture a plate 80mm wide and long enough to extend 20mm past the ends of the cracked area. Bend the galvanized steel plate around firewall, similar to existing firewall.
5. Install the galvanized plate(s) over the cracked area on the front face of the firewall, under the cowl strip, and on the inside of the fuselage side skins. Refer to Fig. 2. Rivet the plate(s) in place from the engine side of the firewall, securing the cowl strip over the plate.
6. This completes the repair. Go to Part C.
