SERVICE LETTER February 28-2005

This Service Letter is for up-dating the “closed” inside labels of the “gull wing door” handles, and general inspection of the handles / doors area.

The affected models are aircraft CH 2000 serial numbers 20-0002 and up.

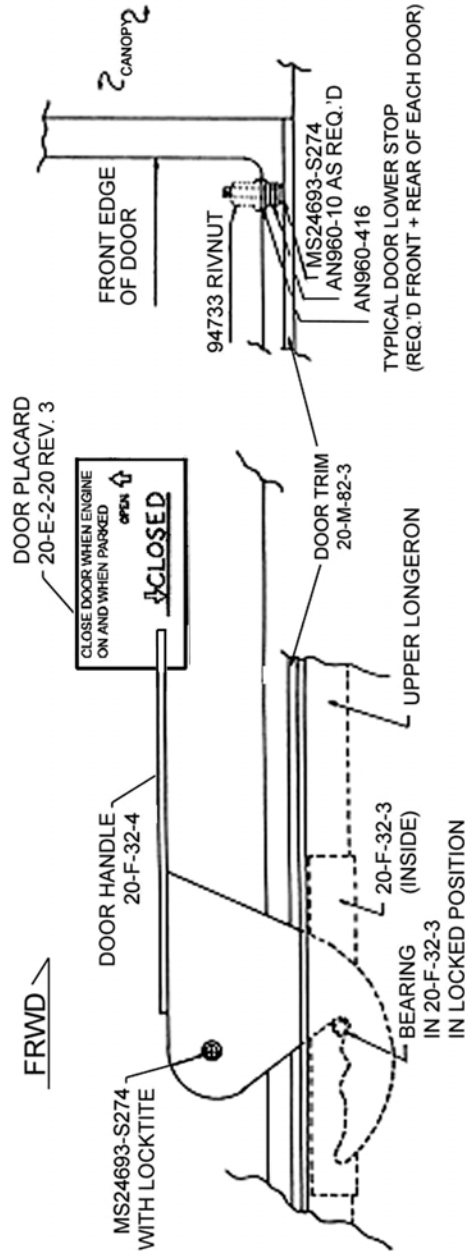
“Gull wing door” handle area inspection, as per schematic on page two of this Service Letter.

- The schematic shows a 10-32 rivnut located front + rear of each door, with washers and countersunk screw. When the door handle is in the closed position, the front + rear countersunk screws must be tight against 20-M-82-3 (channel on top of Upper Longeron).
- Make sure that the door handle position is as per schematic in the “closed” position and that it has “positive locking pressure”.
- Make sure that handle screw MS24693-S274 is tight and that “locktite” has been applied.

- Install label 20-E-2-20 REVISION 3 as per following schematic (on page two), as follows:
 - 1, Remove “Closed” label beside door handle inside door.
 - 2, From inside the aircraft, with the “gull wing doors” closed firmly, make sure that the door handle is parallel with the arm rest. Door handle **MUST** be pushed down all the way.
 - 3, Glue label 20-E-2-20 REVISION 3 with the “closed” line/down arrow, lined up with the handle. Note that there is a left and right label.
- Inspect the bearing in 20-F-32-3 and make sure that it is not worn-through, that it rotates freely and that it is greased.
