## **SERVICE BULLETIN    February 2011**

February 2011, Rev 0

Inspection of Nose Gear Strut weld for possible cracks at the welds. Zenair has been made aware of the weld at the nose gear cracking on an aircraft CH2000. Zenair is recommending that all CH2000 owners inspect the weld area within the next 50 hours, following each hard landing, and annually after.

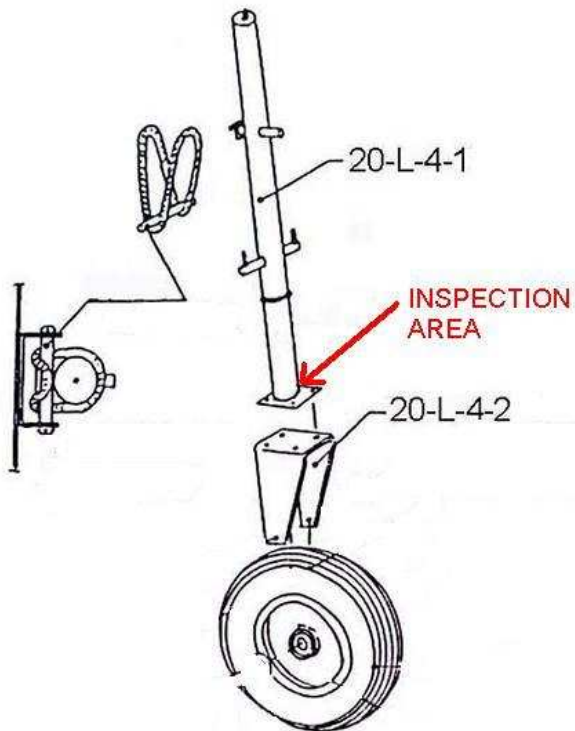
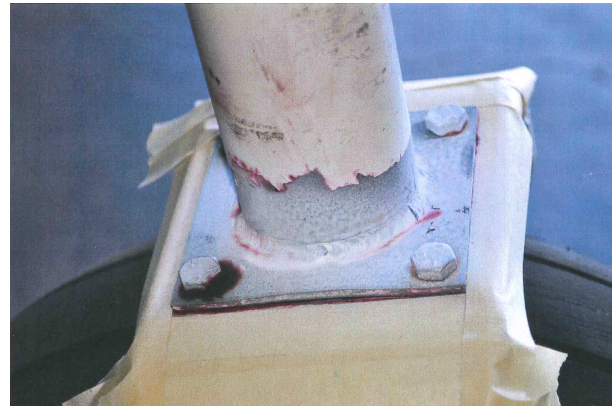
It is assumed that the weld is cracking due to excessive hard nose wheel landing exceeding the design limits. Not straightening the aircraft before landing may result in large side loads on the wheel area. The nose wheel fork may flex and bend the square steel plate welded to the strut tube resulting in possible metal fatigue and eventual cracking.

Inspect the weld area at the bottom of the nose gear strut plate. If the area is getting stressed, the plate attaching the nose wheel fork may start to bend. This is a good indication that the weld area may be cracking. If a good visible inspection confirms that there is no cracking, the inspection is complete. If one is not sure, use the following to inspect:

If any cracks are found, prior to further flight, replace the strut or repair the strut. If no cracks are found, the inspection is complete.

For re-welding of the nose gear bottom plate, do this in accordance with FAA AC No. 43.13-1A. Both the strut tube and plate are made of 4130N steel.
