PFA AIRWORTHINESS INFORMATION

INSPECTION FOR CRACKS IN FRONT TAILPLANE MOUNTS

ZENAIR CH-701

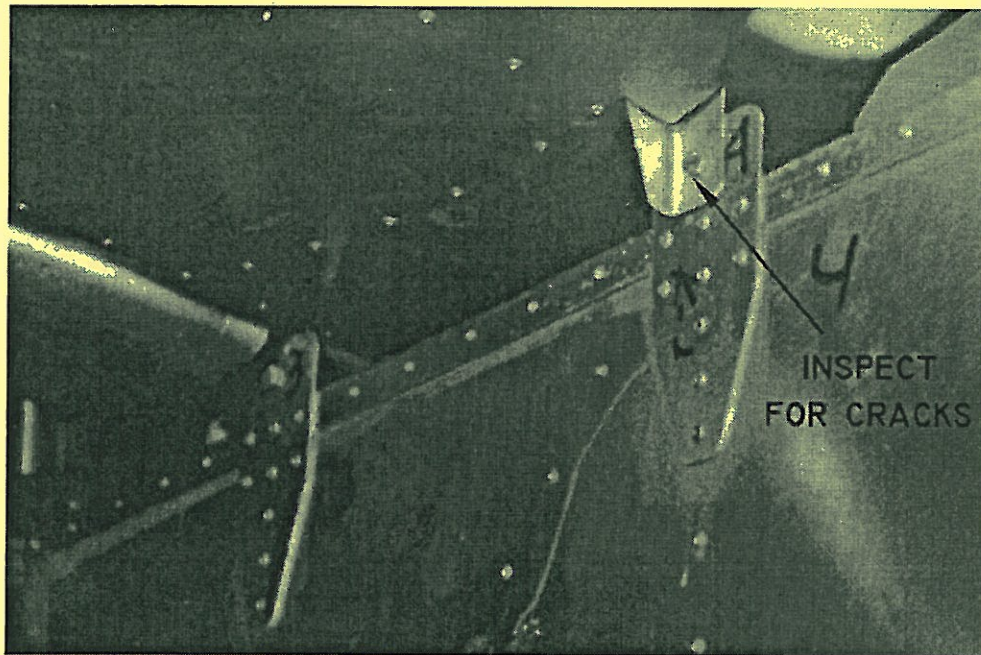
One of our members has discovered cracks in both front tailplane mounting brackets on his CH-701. The hairline cracks were not easy to spot even though one crack stretched from the bolt hole to the bottom edge of the bracket. A thick coat of flexible paint may conceal such cracks altogether.

1. Grasp the leading edge of the tailplane near the tip and gently flex it fore and aft, and up and down. If there are any signs of cracking or undue movement in the area shown above, the brackets must be stripped of paint to allow closer inspection.
2. If cracks are discovered, do not fly the aircraft. Report the finding to PFA Engineering. The normal repair scheme will require replacement of the bracket.
3. On completion of inspection and any rework required, make good the paintwork.

Recommendation: Initial inspection before next flight and thereafter, we recommend as part of your pre-flight inspection.
