Mandatory Action - SAFETY ALERT

<u>Issue Date</u>

January 2017, Rev. 2

Inspection of the Horizontal Stabilizer tail attachment brackets

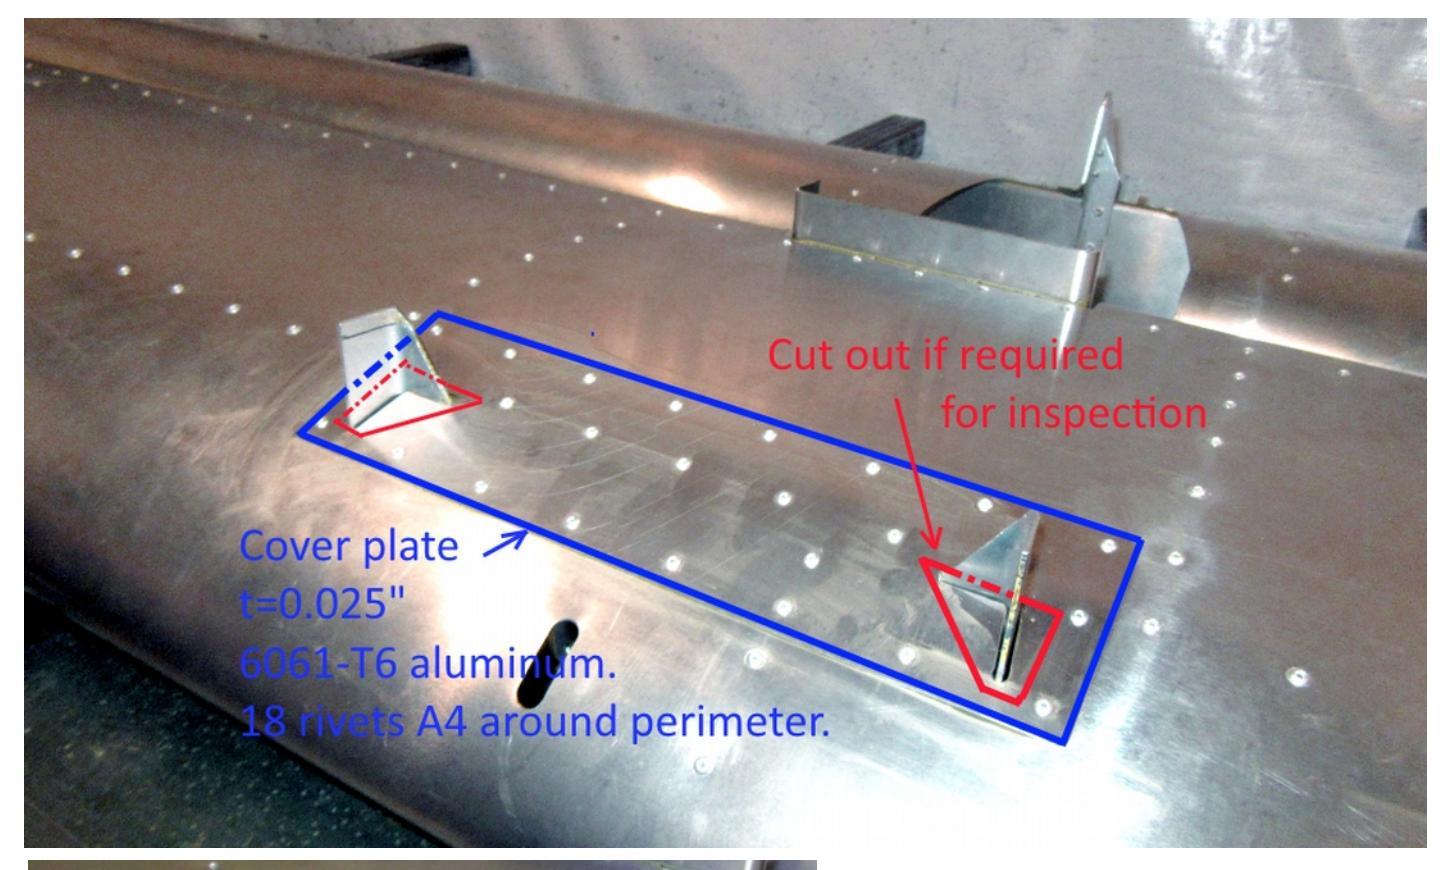
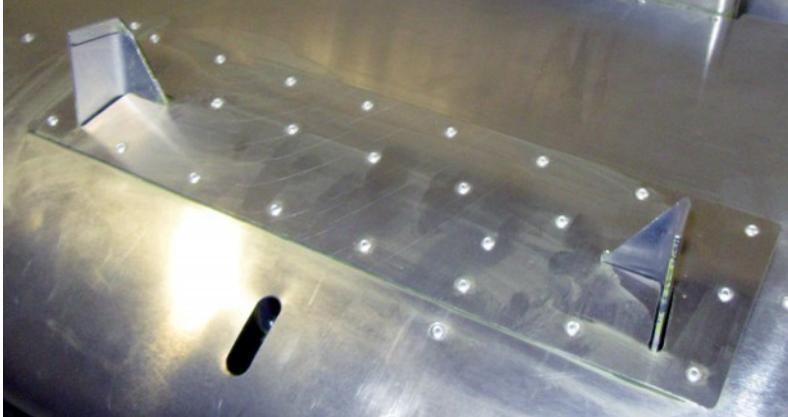
If you are not able to properly inspect inside the H.S. forward attachment brackets and associated rivets, cut out the area as shown in the following sketch. Add a cover plate after inspection as shown. Fasten into place with 18 rivets A4 around the perimeter of the cover plate.

For inspection, cut out enough material to properly inspect all the rivets attaching the brackets to the spar. If the brackets are to be replaced, the cut out holes can be made larger. See FAA AC-43-13-1B section 4-32, Figure 4-16 when adding a covering.

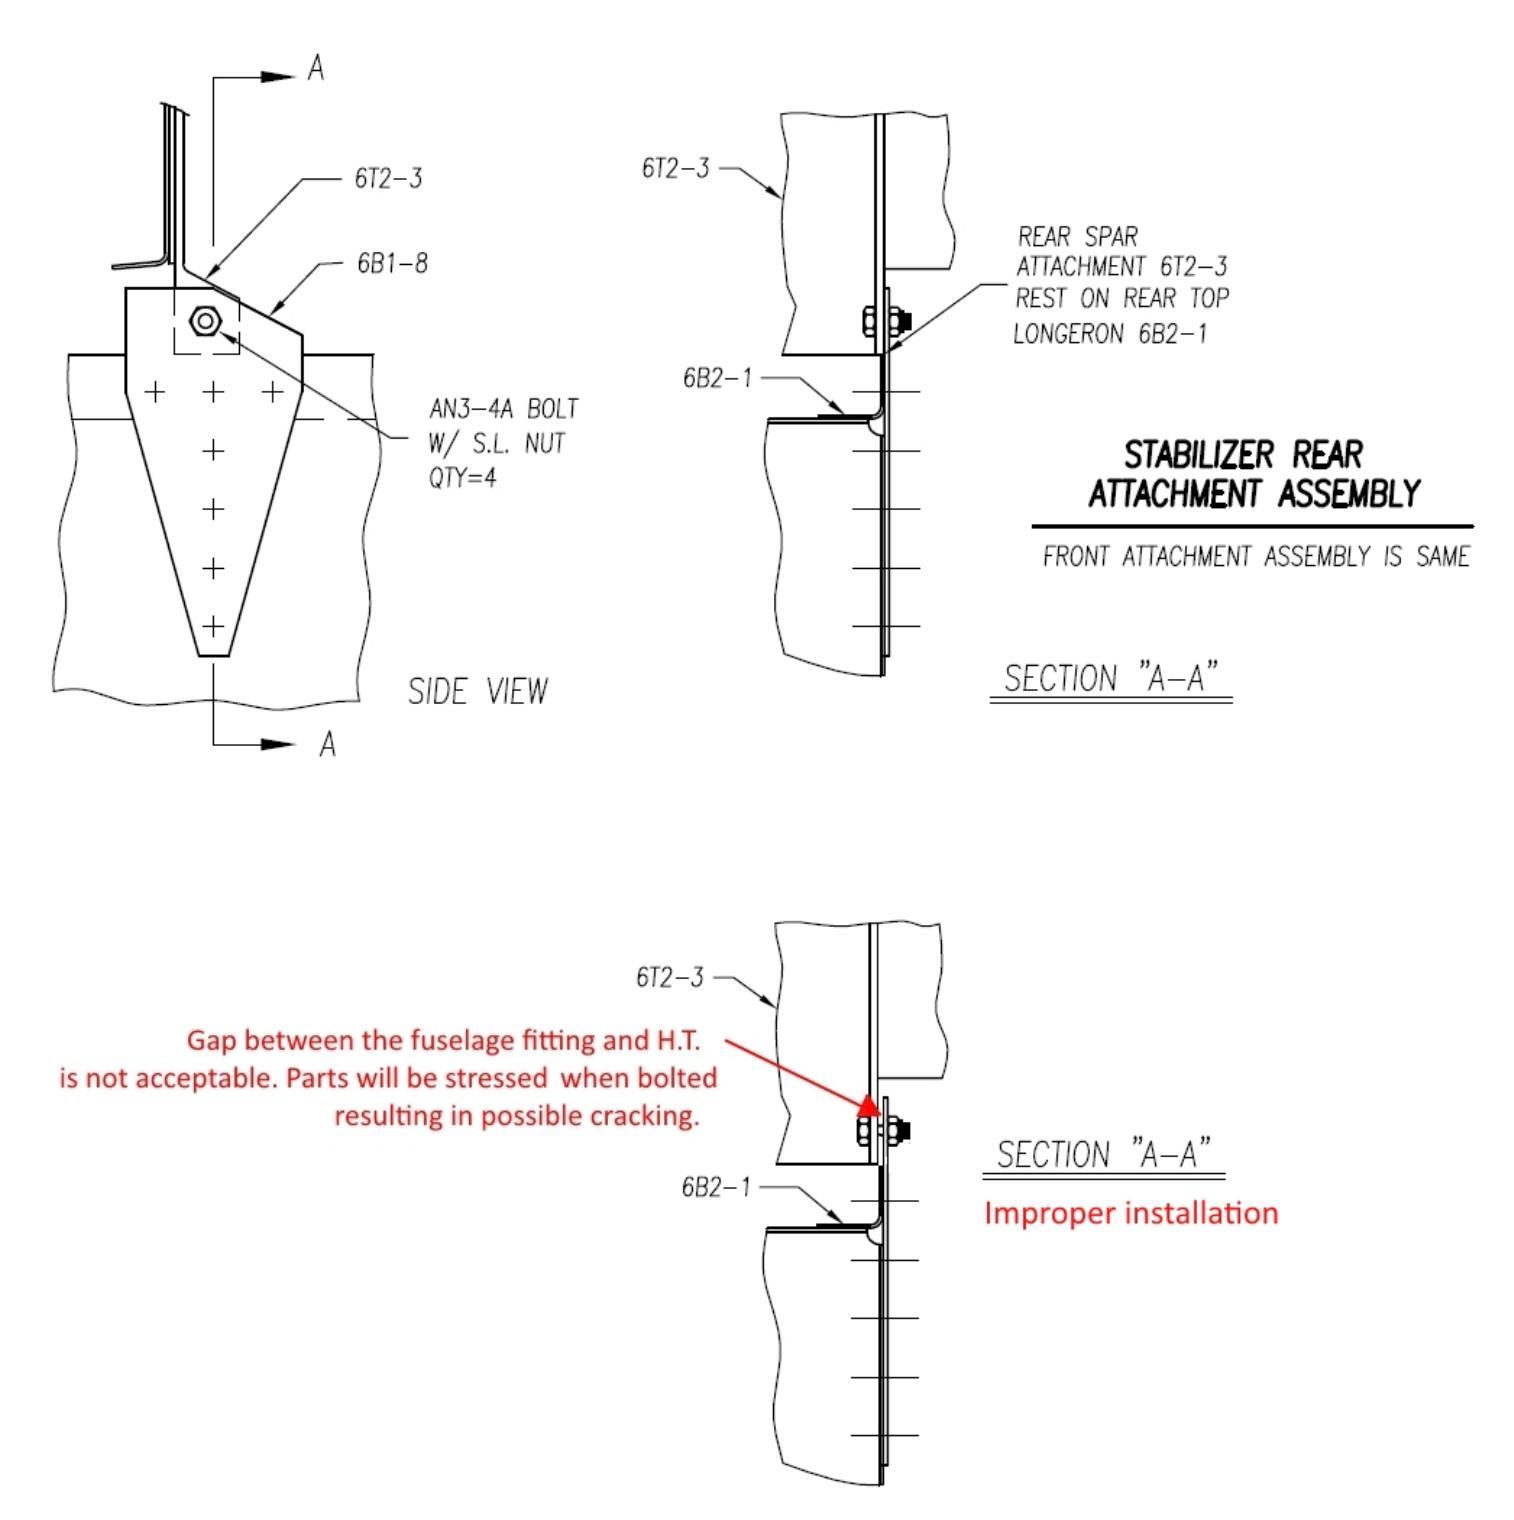
Above assembly drawing is for a typical CH 601 aircraft. Each CH design is different. Use your airframe model blueprints (drawings) and not the above example for inspection and installation.

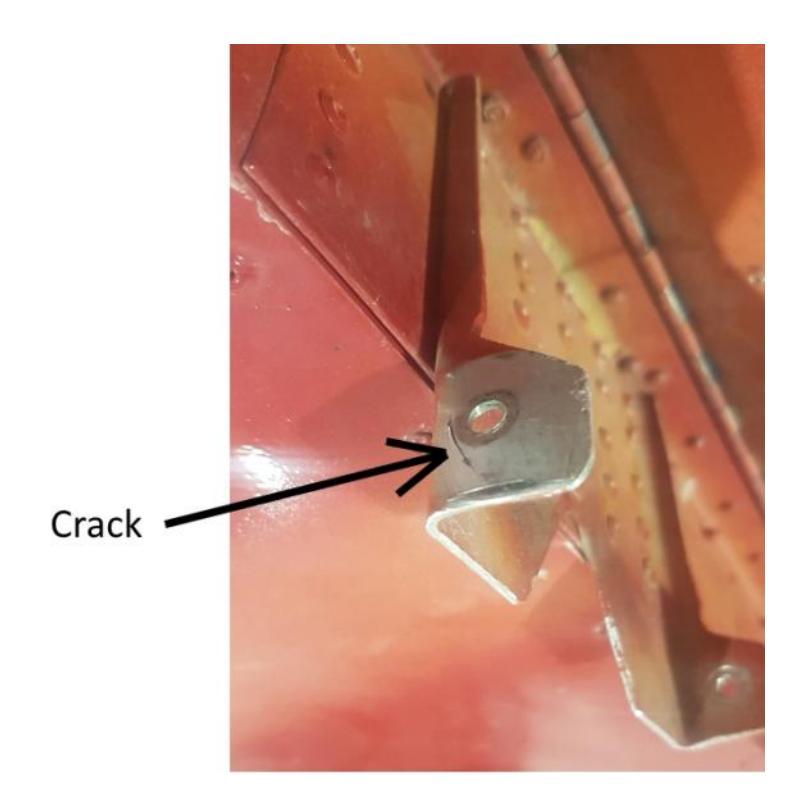
View of H.S. rear attachment bracket. A crack is developing in the part. Part must be replaced.

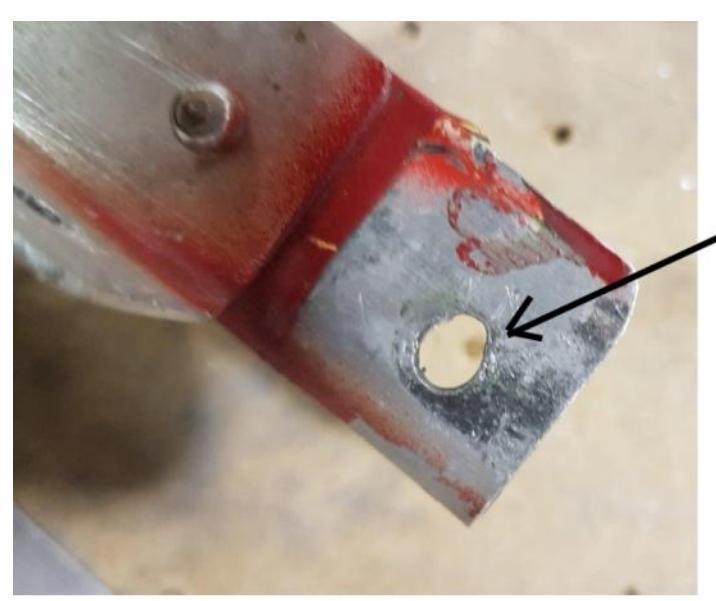
Strange hole.
Part must be changed.

View of H.S. front attachment bracket. Bolt hole was not properly drilled. Part must be replaced.

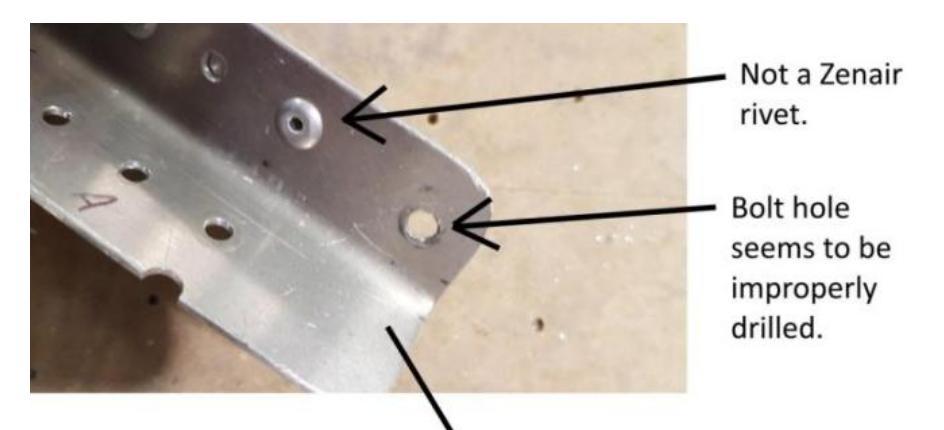
Bracket attaching horizontal stabilizer to fuselage. This is not an original bracket.

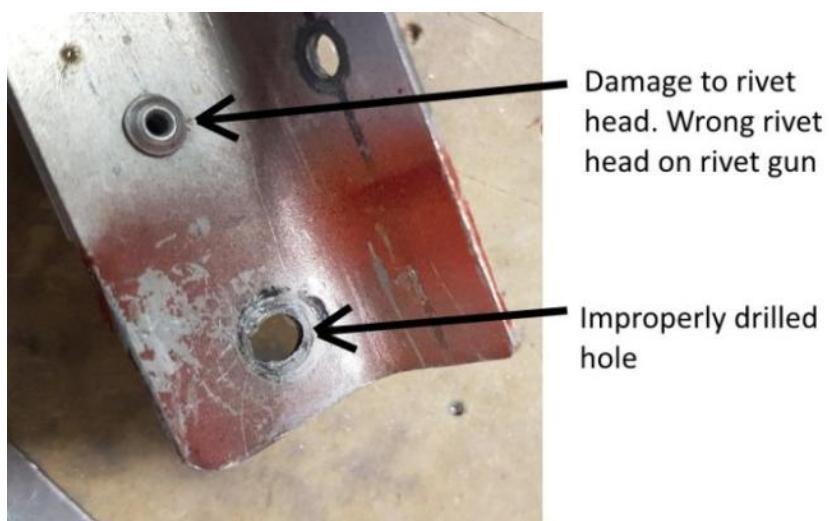
Above parts must be replaced. Check your drawings, construction manual for the proper edge distance on the bolt holes.

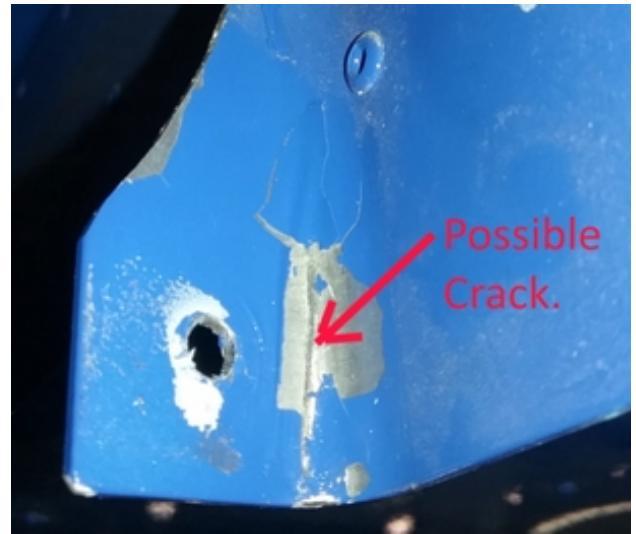
Above part must be replaced.

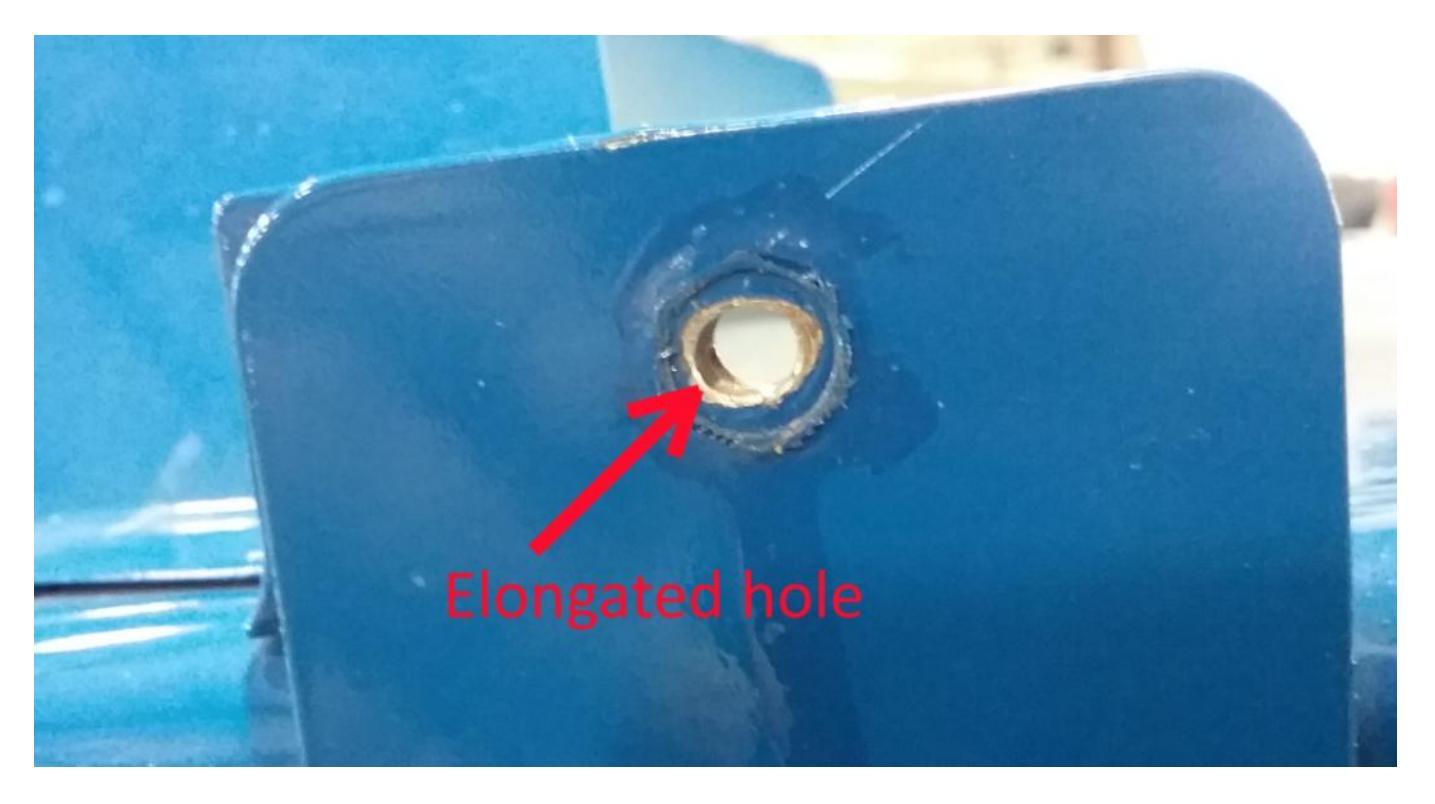
Above part must be replaced. It is possible that due to an elongated hole, the stabilator bracket cracked as the bolt was moving in the hole.

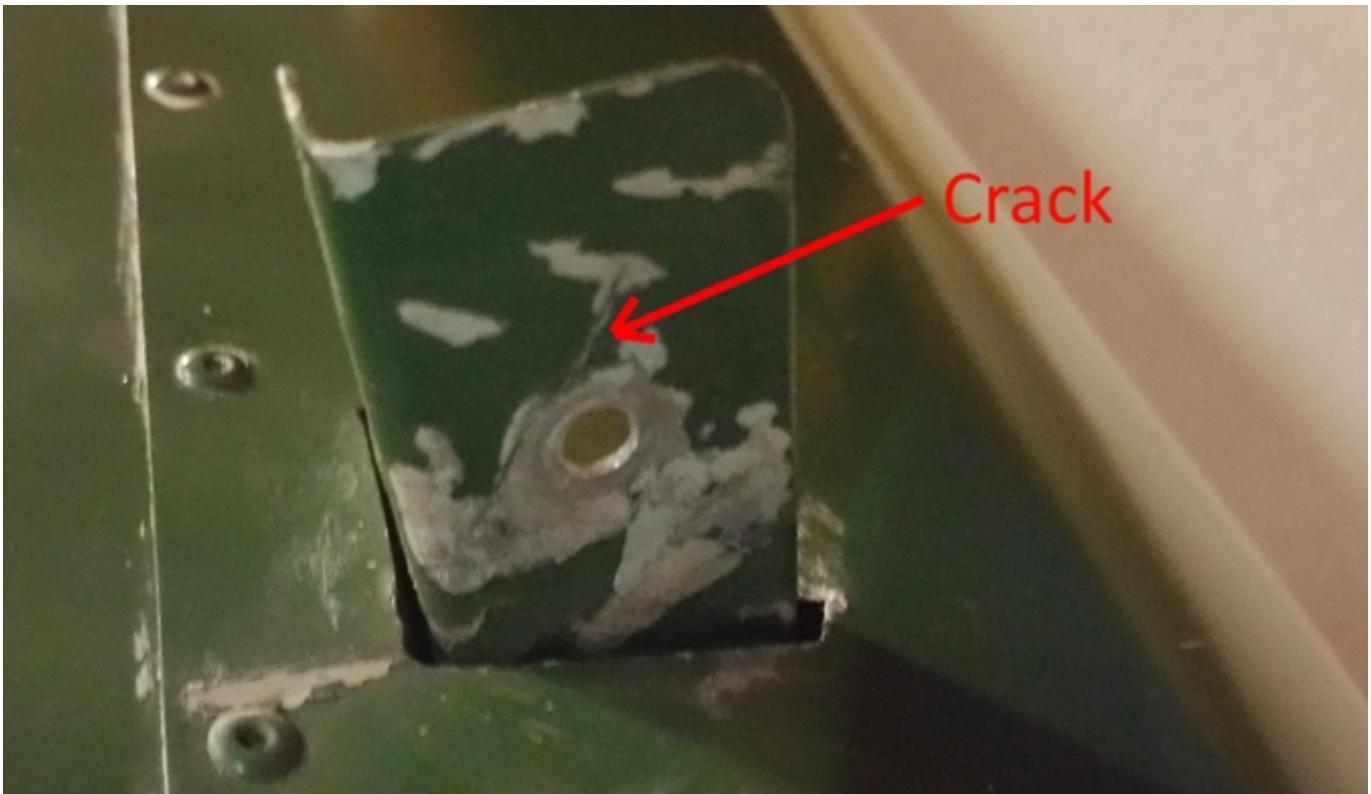
Above part must be replaced.

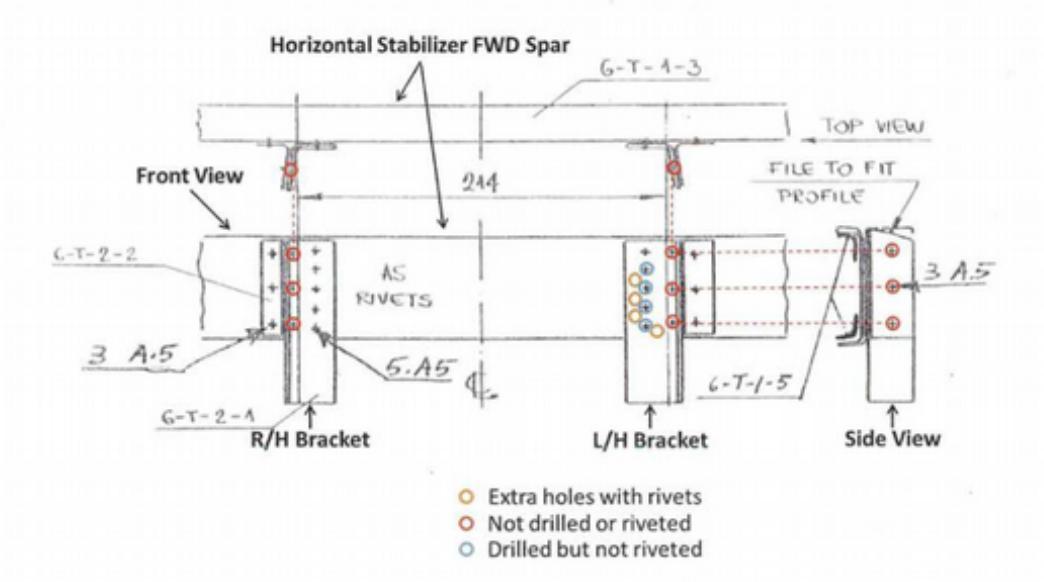
Figure 1. Horizontal stabilizer forward structural attachment—aircraft drawing. (source: Zenair, with digital annotations by the TSB)

As per the drawing (Figure 1), the horizontal stabilizer forward structural attachment is designed to be constructed by riveting two aluminium angles (attachment bracket 6-T-2-1 and attachment doubler 6-T-2-2) with three rivets back-to-back and connecting the attachment bracket to the front surface of the forward spar (6-T-1-3) with five rivets.

In the actual installation, the three rivets connecting each attachment bracket to the associated attachment doubler were missing and the required holes were not drilled. Four additional holes were drilled through the left attachment bracket and continued through the forward spar. Rivets were installed in all of these additional holes; however, they were only installed in one of the five holes specified in the drawing.

Structural integrity of the horizontal stabilizer forward attachment point was compromised on both sides because of the missing rivets, and the strength of the forward spar itself was reduced because of the extra holes.
