ULPOWER AERO ENGINES N.V.

SERVICE BULLETIN

Service Bulletin No. 2020-01

SUBJECT: broken spring in oil thermostat

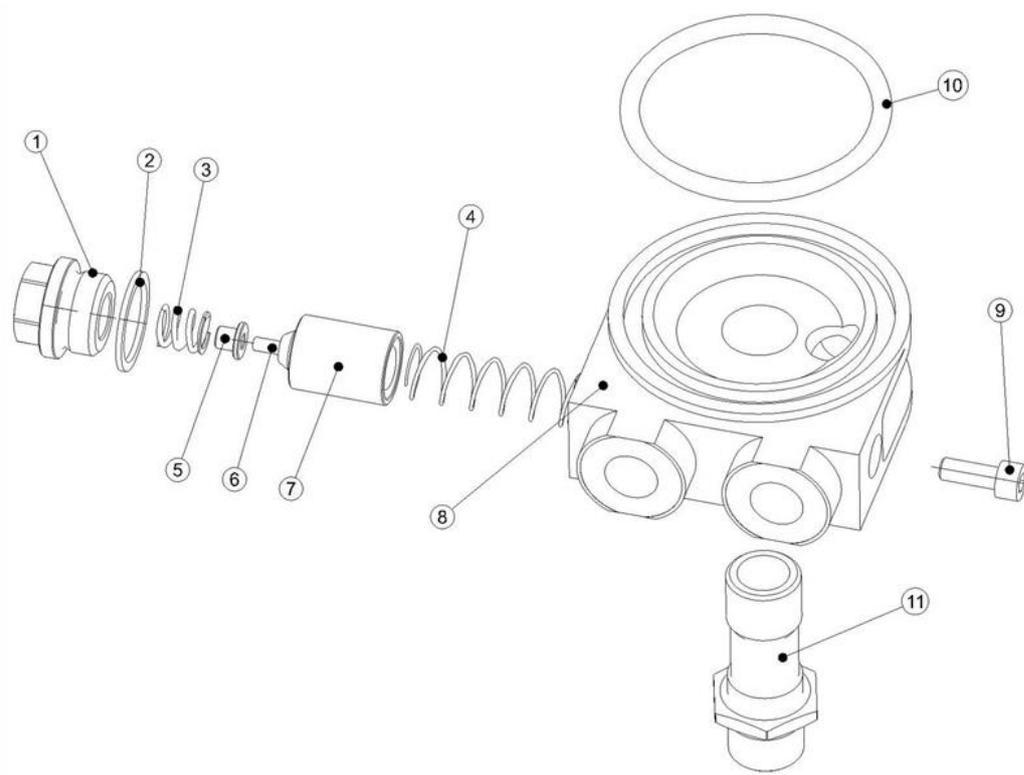
Parts needed : Item 3 in drawing below F2010010 small spring
Item 4 in drawing below F2010020 large spring
Item 2 in drawing below S3222715 Copper sealing

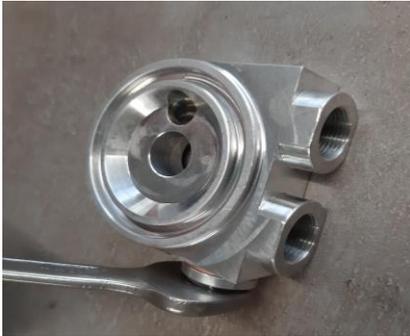
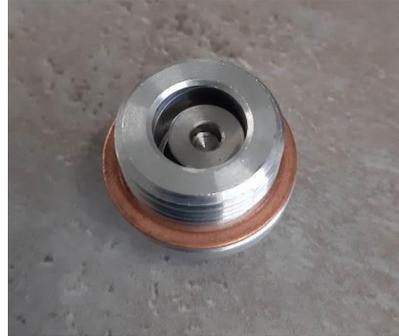
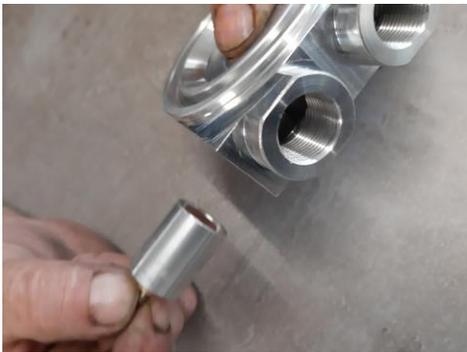
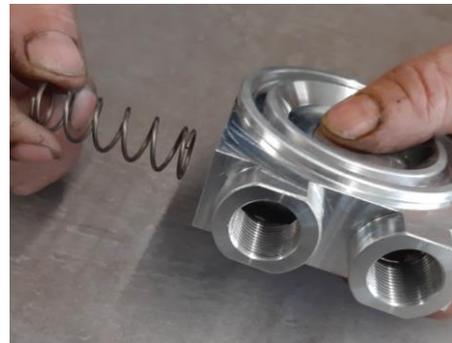
- 1) Unscrew the plug M22 X 1.5 (item 1). Remove the spring (item 3), replace the oil seal, (item 2) and put the spring holder (item 5) back in the plug. Put them aside.

When unscrewing, remember the spring is under pressure. Make sure you don't lose the spring holder !

- 2) Remove the bimetal actuator and bimetal actuator cover (item 6 + 7) and put them aside.
Replace the large spring (item 4) with the new one. Slide the bimetal actuator and cover back in.

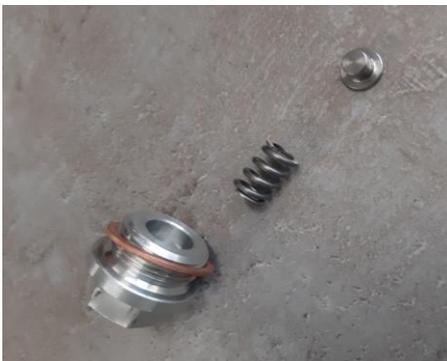
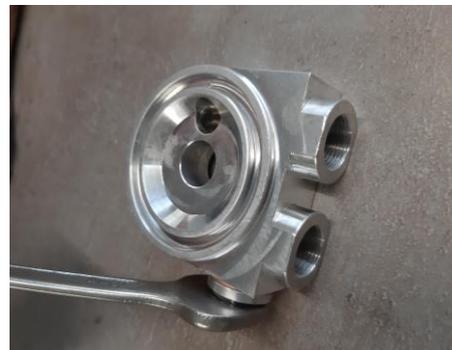
- 3) Insert the small spring (item 3) into the plug (item 2) and finish off with the spring holder (item 5).
Torque the plug (item1) to 20Nm

After this replacement, check if the normal oil pressure is achieved within 5 seconds and check for oil leaks
